# Case Study: Interconnectivities between Shoreline Type and Structural Vulnerability

The Role of Mangroves in Mitigating Damage due to Hurricane Irma in the Florida Keys

Tori Tomiczek, Kelsi Furman, Brittany Webbmartin, Kiera O'Donnell, Steven Scyphers

ICCE 2018 Short Course: Natural and Nature-Based Features (NNBF) For Coastal Resilience

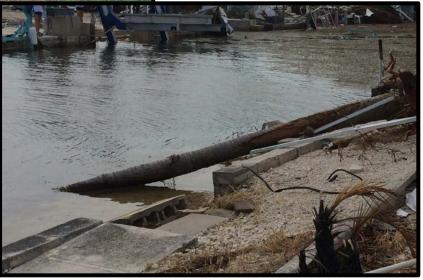
Mangrove: broken

branches, loss of

foliage, regrowth

Revetment: rocks displaced

Sandy Beaches: erosion

Bulkhead: cracks, undercutting, structural collapse 10
