USACE Green Breakwaters Demonstrate Engineering With Nature through Pilot Projects

Great Lakes Green Breakwaters Study

Cleveland East Arrowhead Breakwater Project

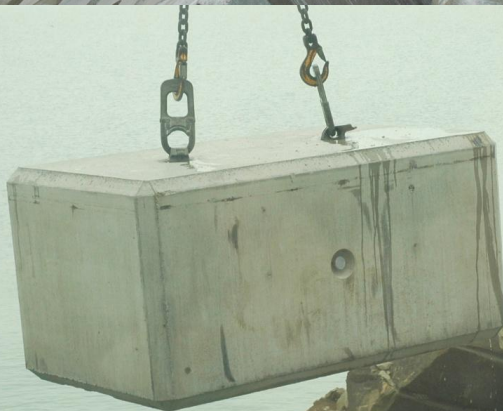
8' x 5' x 4' Repair Toe Block

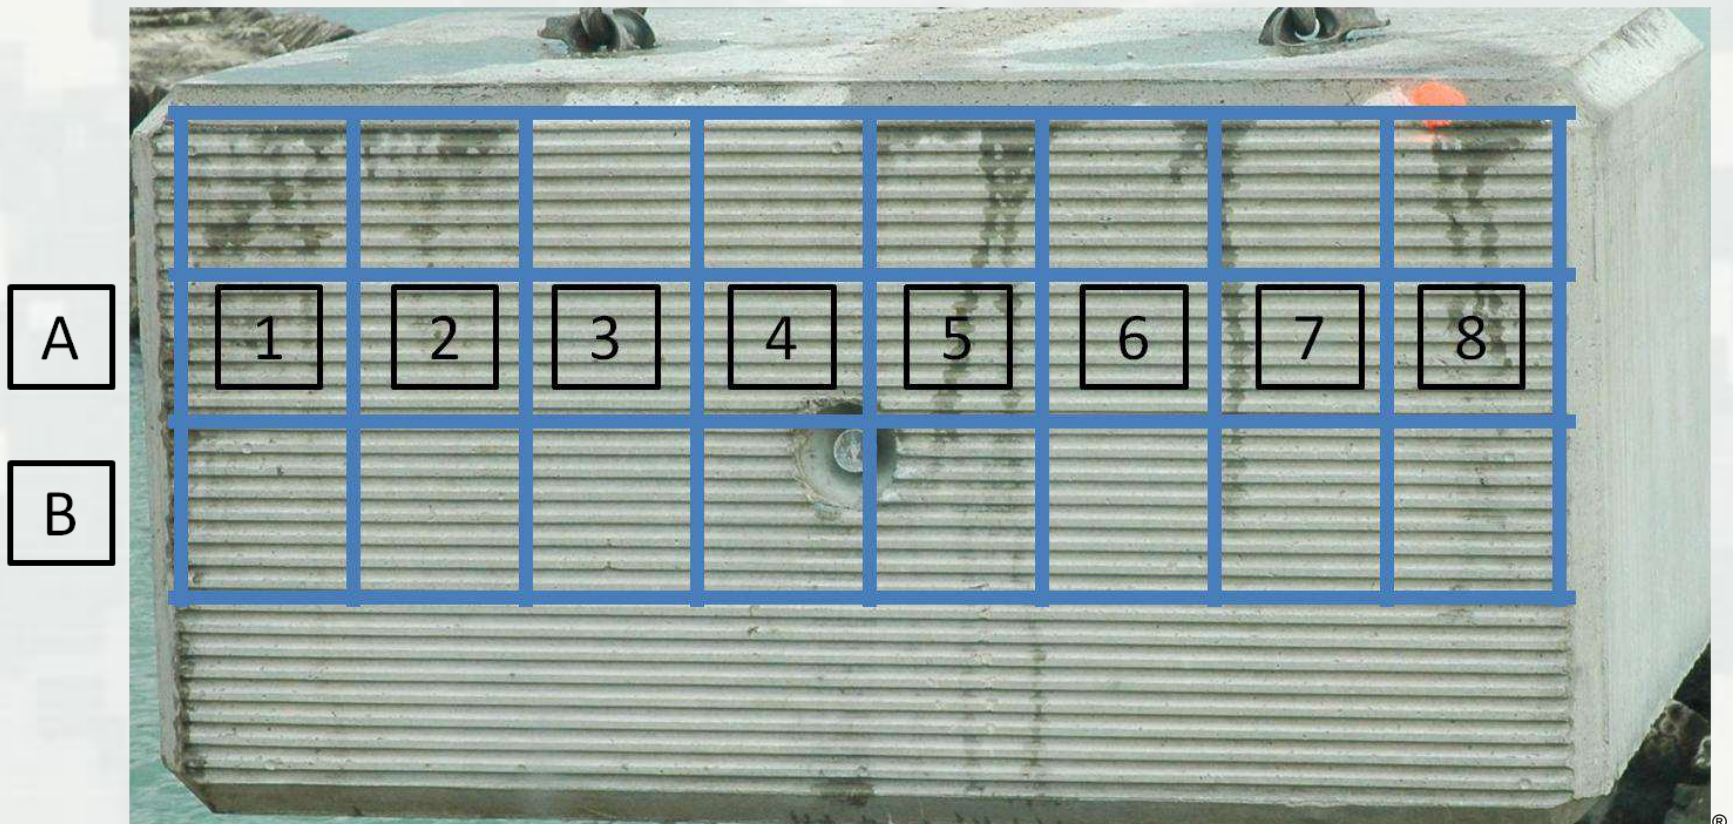
Sampling Grid

- Top row was not submerged

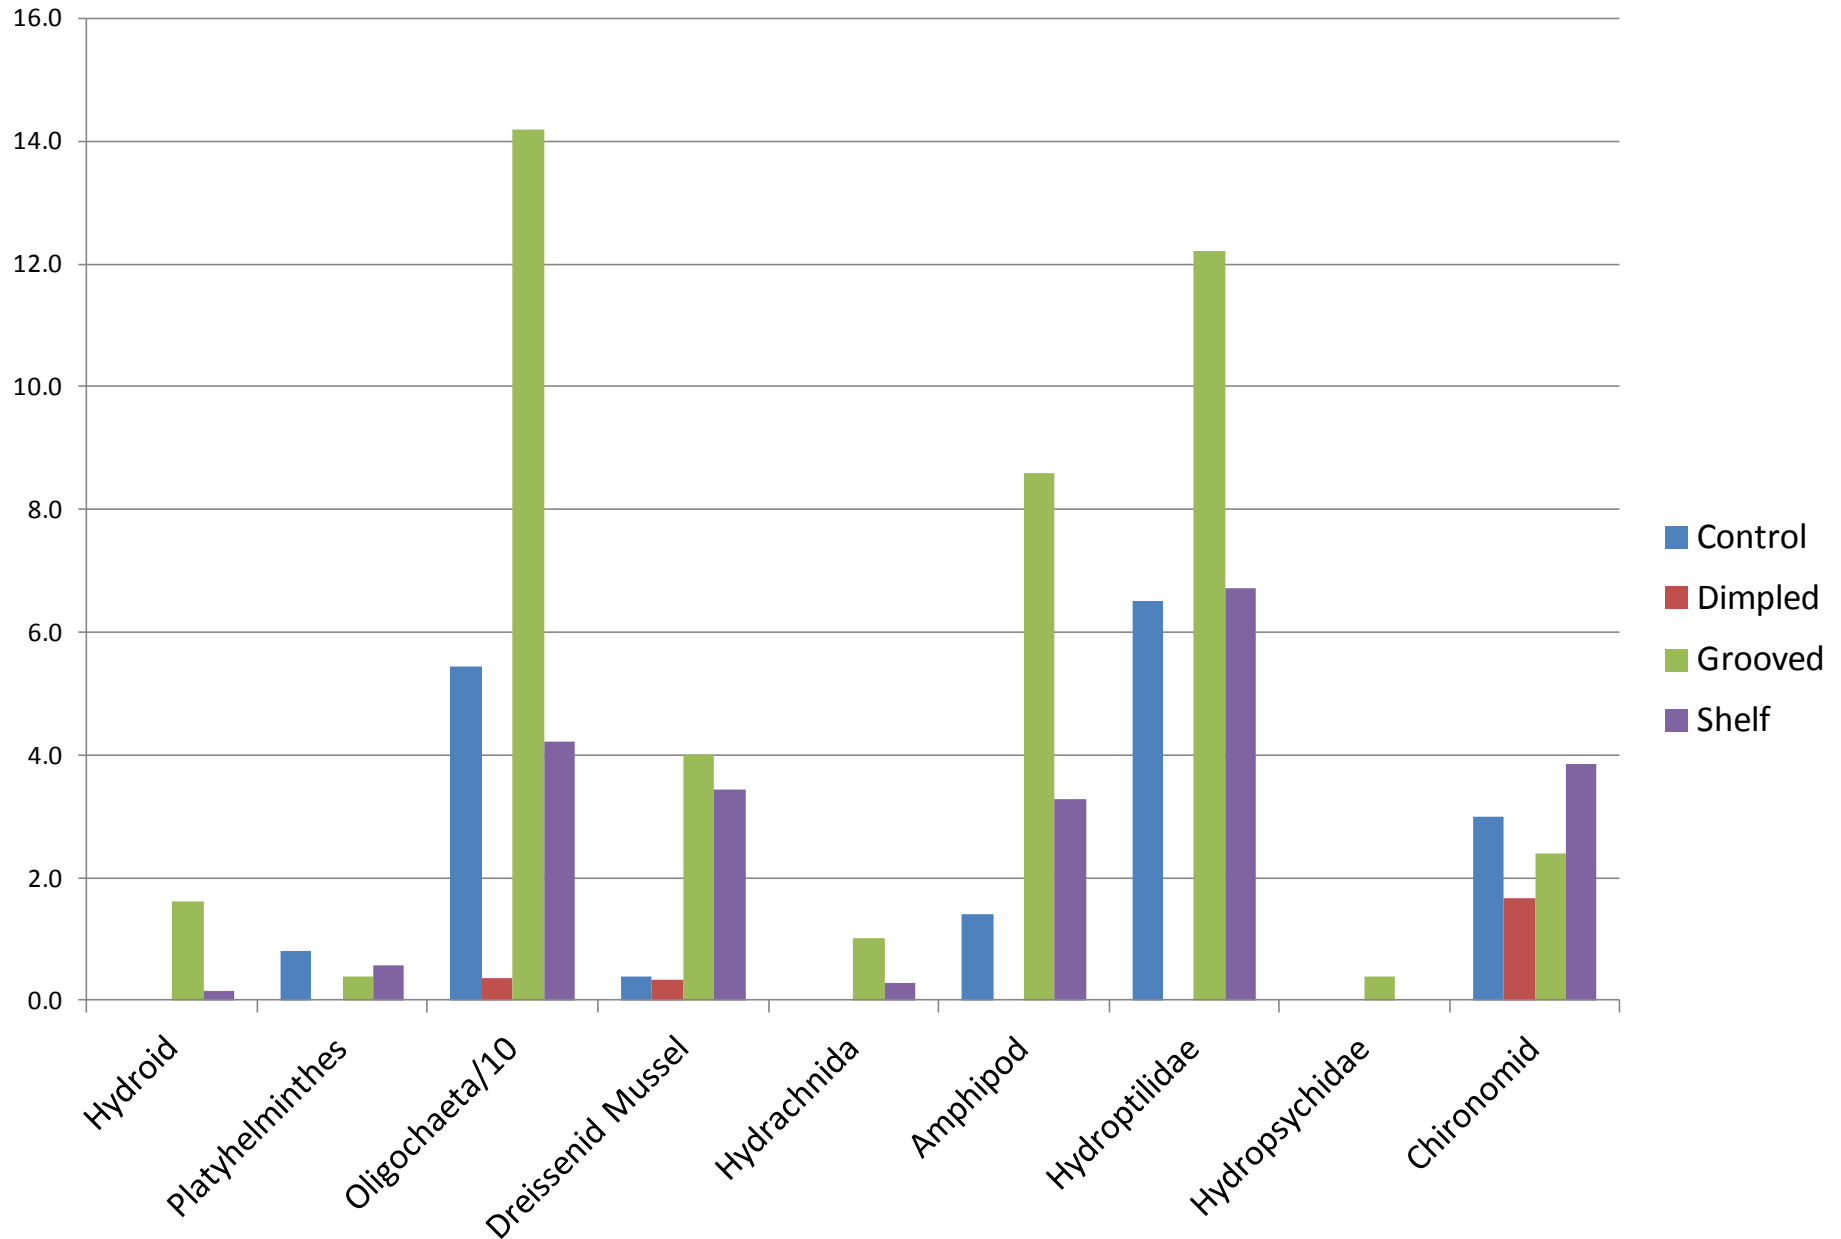
Preliminary Results – Abundance – October 2012

- Initial colonization (Oct. 2012) greater for most groups on grooved blocks
 - Invertebrate secondary production increase
- Potential to provide juvenile fish refuge
- Awaiting sample processing and analysis from other monitoring events
