The Use of the Iñupiaq Technique of Tundra Sodding to Rehabilitate Wetlands in Northern Alaska

Timothy C. Cater,¹ Charles Hopson² and Bill Streever³

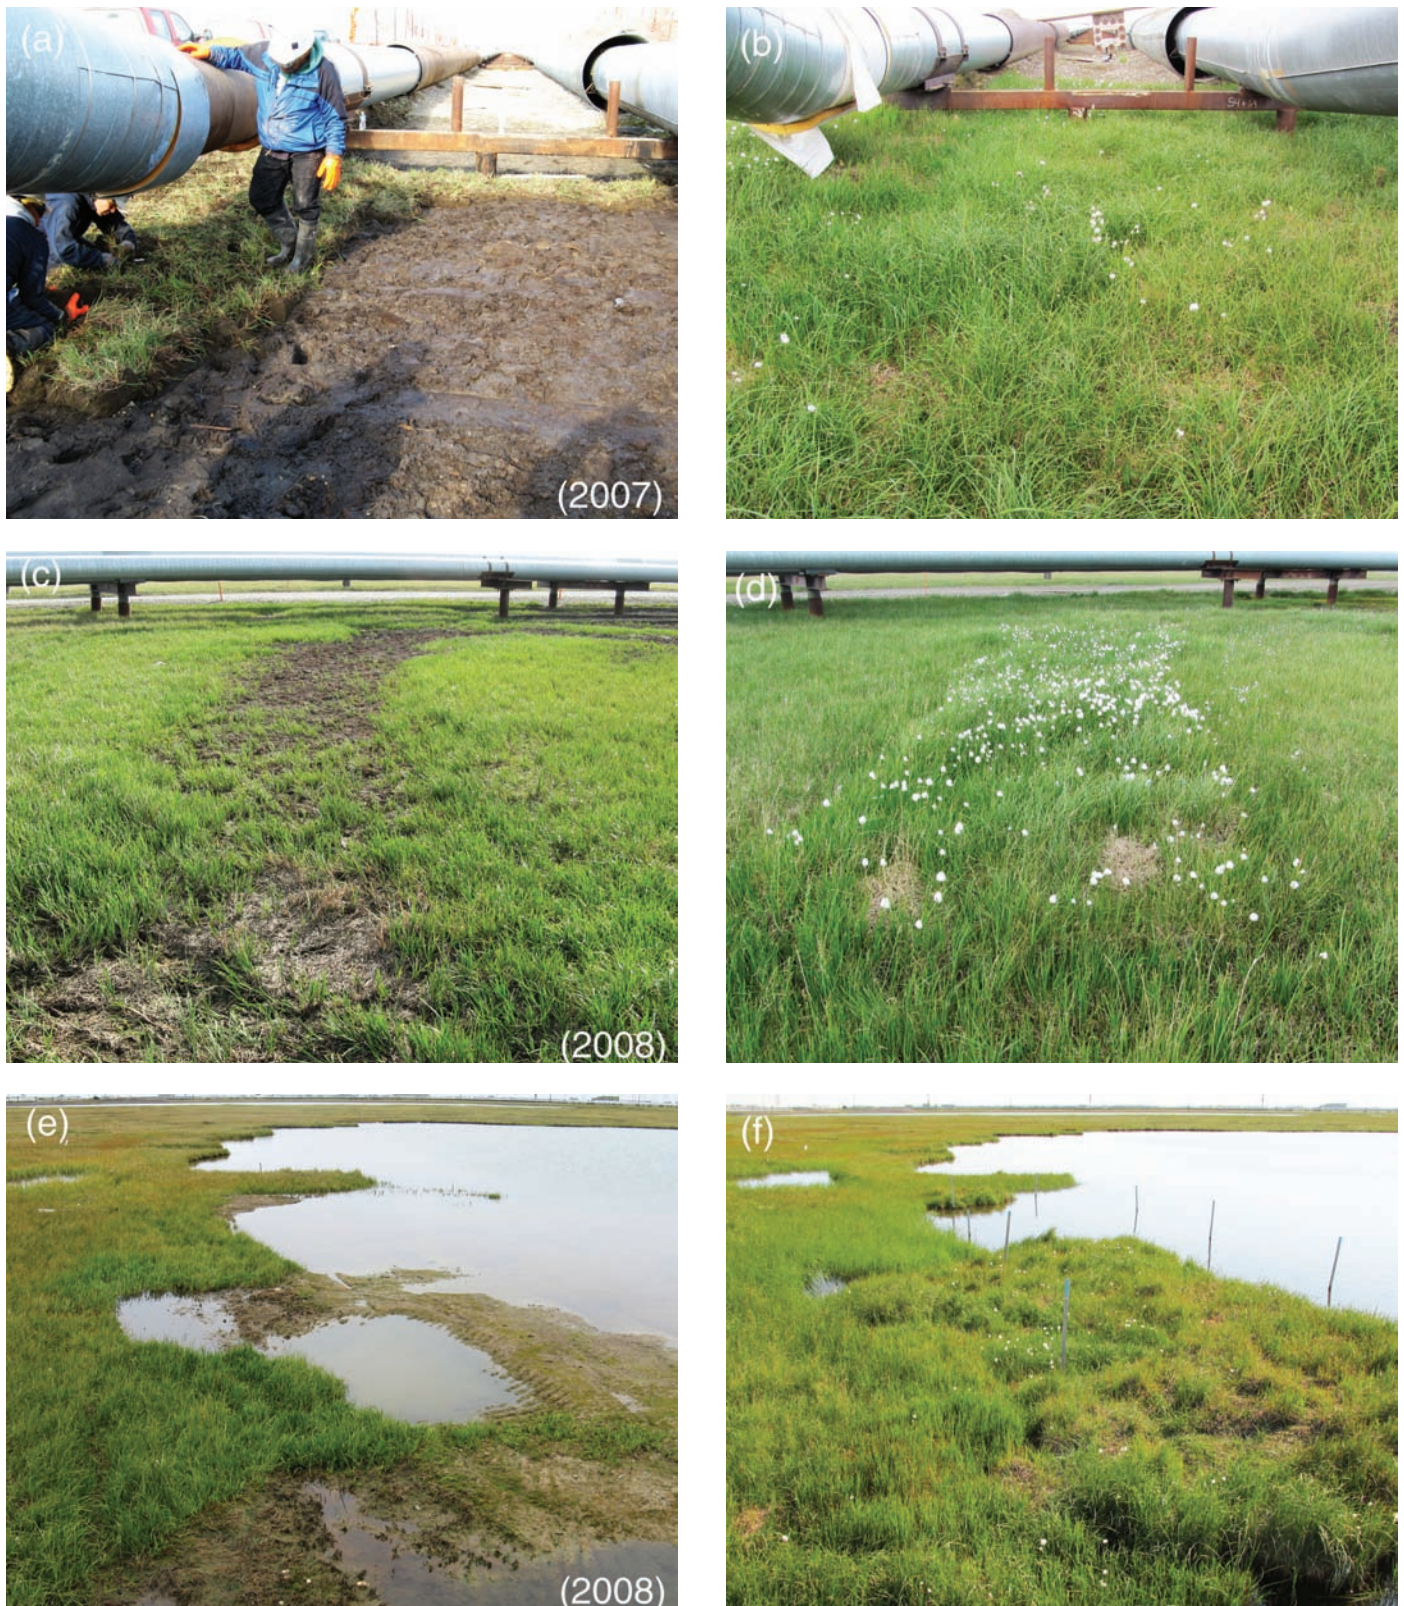
FIG. 2. View of sites before sod was transplanted (left) and again in 2012 (right). (a, b) Site A; (c, d) Site B; (e, f) Site C.

At Sites A, B, and D, sod was carefully placed by hand to maximize contact between the sides of adjacent blocks (Fig. 2a). At Site B, where sod was placed in the portions of the ice-wedge troughs that had subsided (Fig. 2c), blocks were sometimes stacked on top of each other to ensure that plants in the top layer of sod were above the water surface. At Site C, the large sod blocks were placed as close to each other as possible (Fig. 2f). Portable skate wheel conveyors, typically seen in warehouses, were used to move sod under the pipelines and across a site, dramatically reducing the distance workers had to carry sod blocks. Plywood supported the conveyors and provided a stable surface for workers, which limited physical damage to the ground surface.

Vegetation in the transplanted sod appeared healthy and productive at each site in 2012 (Figs. 2b, 2d, 2f, and 4a). New growth of roots between blocks and into the underlying soil was clearly visible upon close inspection. However, we did observe patches of dead vegetation (Fig. 4b) at each site in 2012, apparently the result of grazing by tundra voles (*Microtus oeconomus*) or other microtines, as well as their burrowing between and through some of the sod blocks.

The absence of depressions where surface water can accumulate suggests that the elevation of the ground surface after tundra sodding has remained relatively stable (Figs. 2b, 2d, 2f, and 4a). Quantitative measurements at Site C showed that the ground surface elevations at three points where tundra sod was transplanted were 2–20 cm higher in 2012 than in 2007, before sod was planted. Thus, although tundra sodding did not prevent thermokarst, the thickness of the sod pieces (up to 60 cm thick) offset the subsidence that did occur, resulting in the treated areas' having an elevation similar to the original tundra surface. In contrast, the ground surface elevations at the 16 stations without tundra sod were 5–78 cm lower in 2012 than in 2007. The ground surface at most of these stations has become incorporated into the adjacent pond.

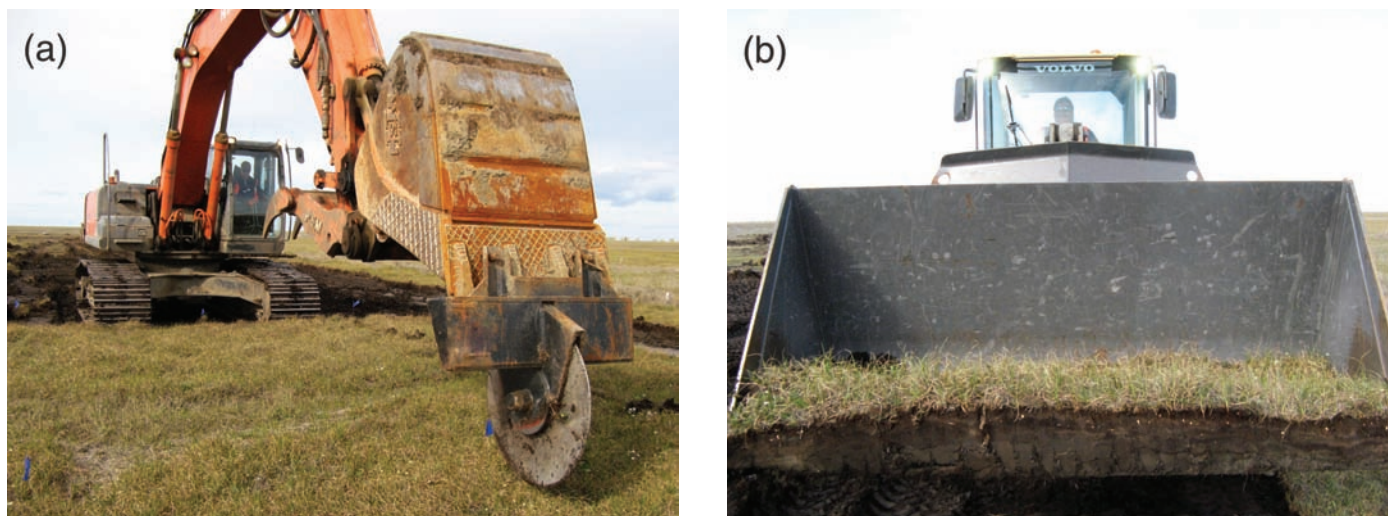
FIG. 3. (a) The mechanical sod cutter (*nuna ulu*) making vertical cuts at the harvest site, and (b) the loader used to remove large blocks of sod.

easily cutting to a depth of about 0.5 m (Fig. 3a). A new Iñupiaq phrase, *nuna ulu*, meaning “land knife,” was coined to describe this rolling steel disc. An excavator bucket removed 0.4 m³ of sod with each load. The most efficient harvesting method was used at Site D in 2010: the *nuna ulu* and serrated knives were used as before, but with a large front-end loader with a larger bucket, which removed approximately 2.9 m² of sod as a single block (Table 1, Fig. 3b).

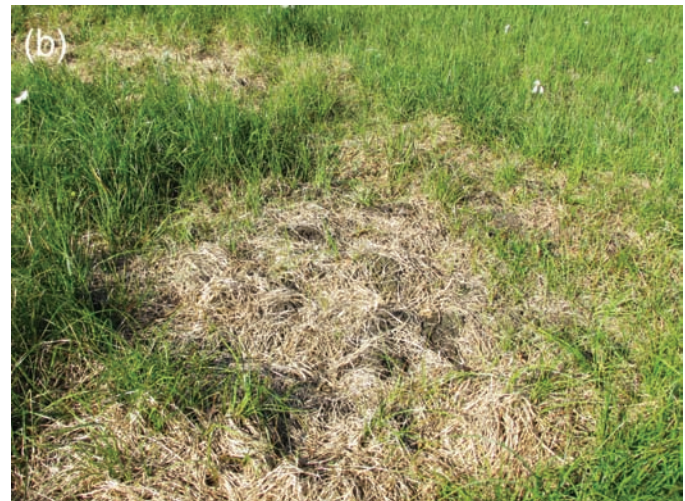
FIG. 4. (a) The sodded area at Site D surrounded by undisturbed tundra, and (b) a patch of dead vegetation attributed to microtine activity after tundra sodding at Site B.
