Promoting SAV Habitat Sustainability through Innovative Dredging and Placement Practices

Emily Russ and Safra Altman
USACE ERDC EL
CERF 2021

Barnegat Bay, NJ – Oyster Creek Channel

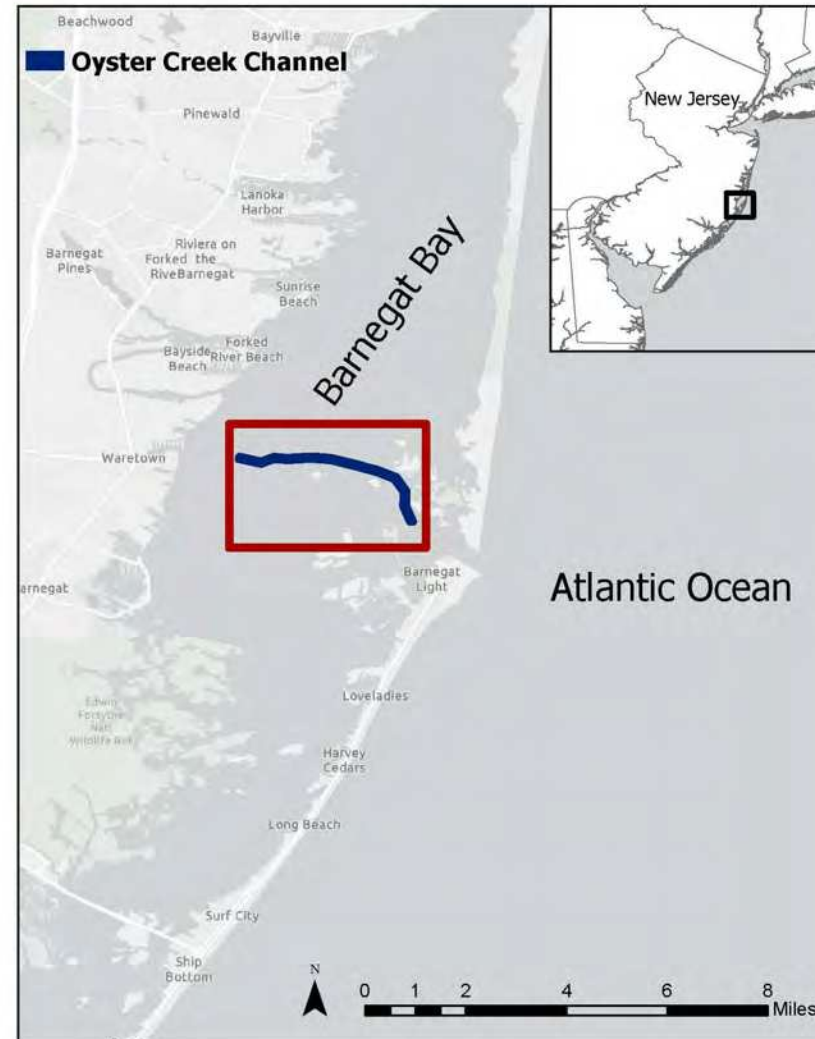
- **Oyster Creek Channel – Dredged ~2 years between 1981-2017**
- **Material placed at 2 open-water disposal areas that became islands**
 - **26A (East) – inactive since 2008, now a Heron Rookery**
 - **26B (West)**

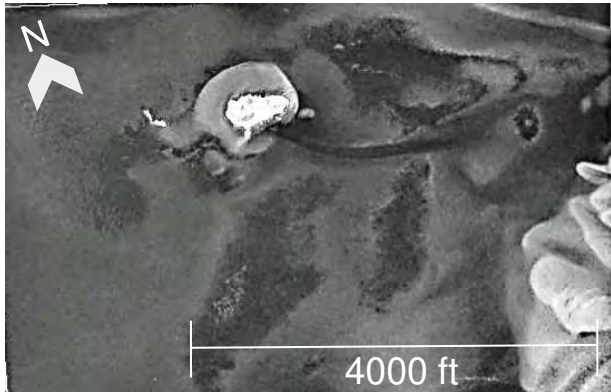
March 1995

Last placement: 1991
Next placement: 1996

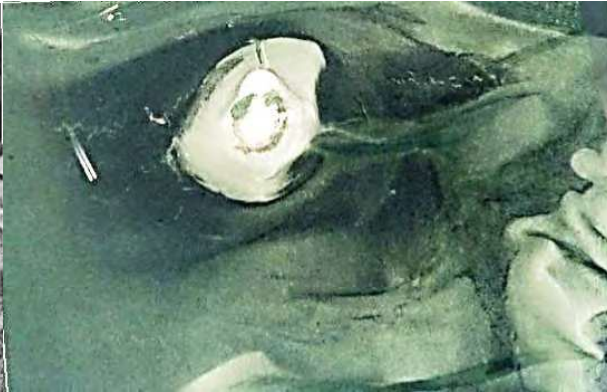
May 2008

Last placement: 2004
Next placement: 2009

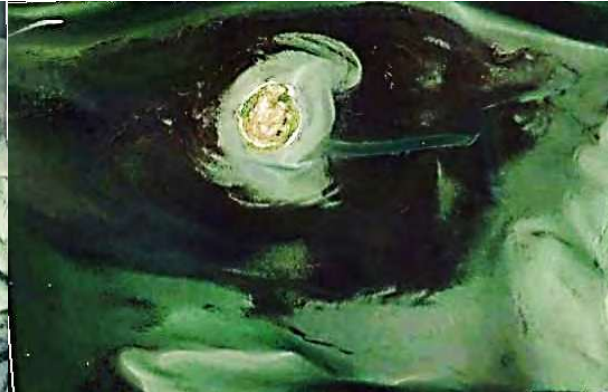
September 2013

Last placement: 2010
Next placement: 2015

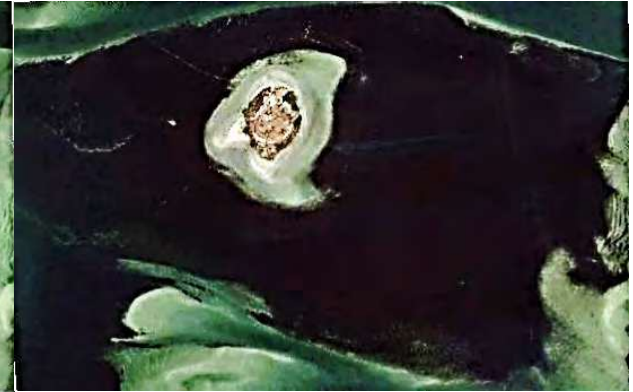
October 2017

Last placement: 2017*

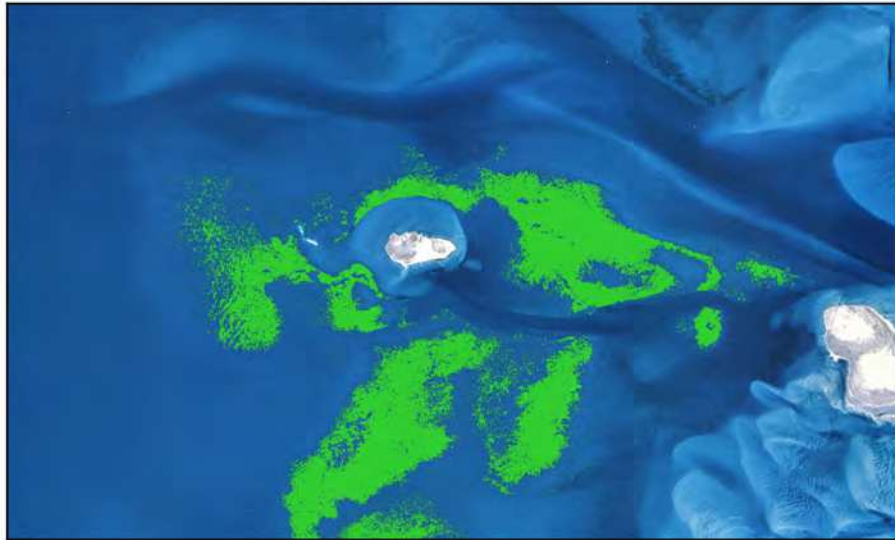
NAIP Imagery: 1995

SAV area: 0.59 km²

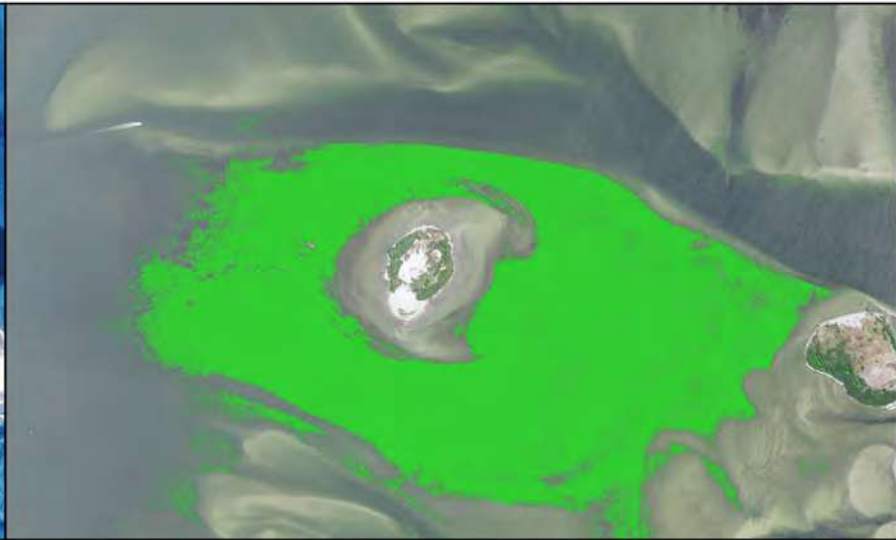
NAIP Imagery: 2015

SAV area: 1.57 km²
