Levee impacts on riverine ecosystems

Mediating effects of woody vegetation

Doug Shields, Jr.

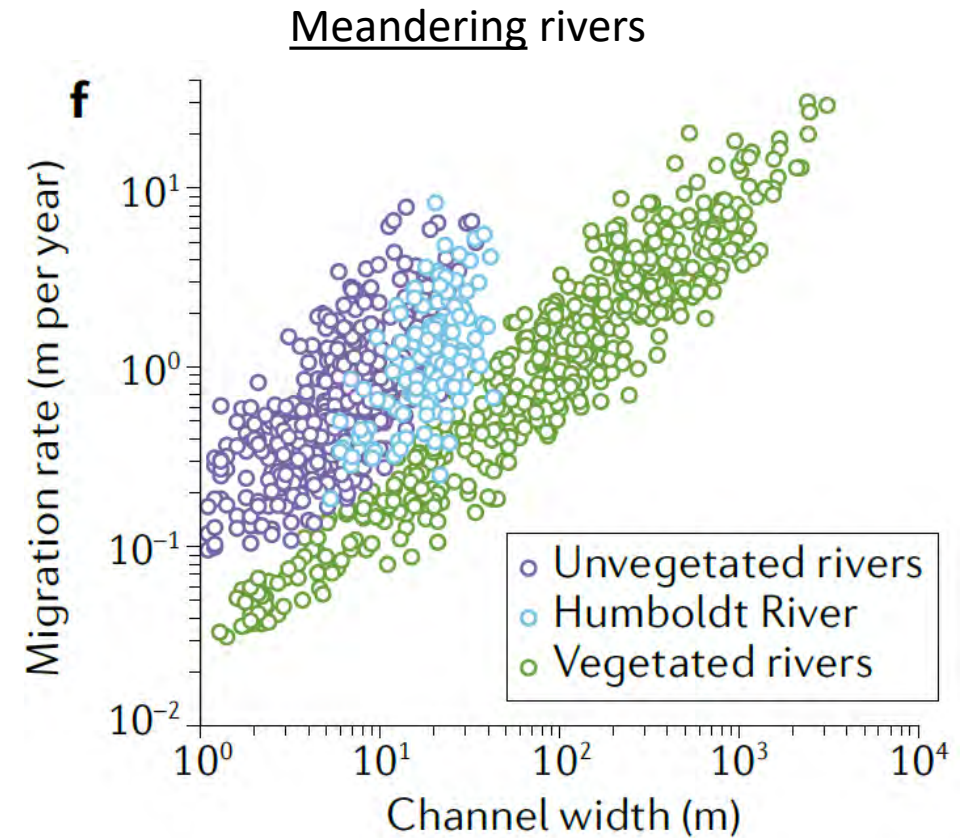
Lateral migration rates slower for vegetated floodplains

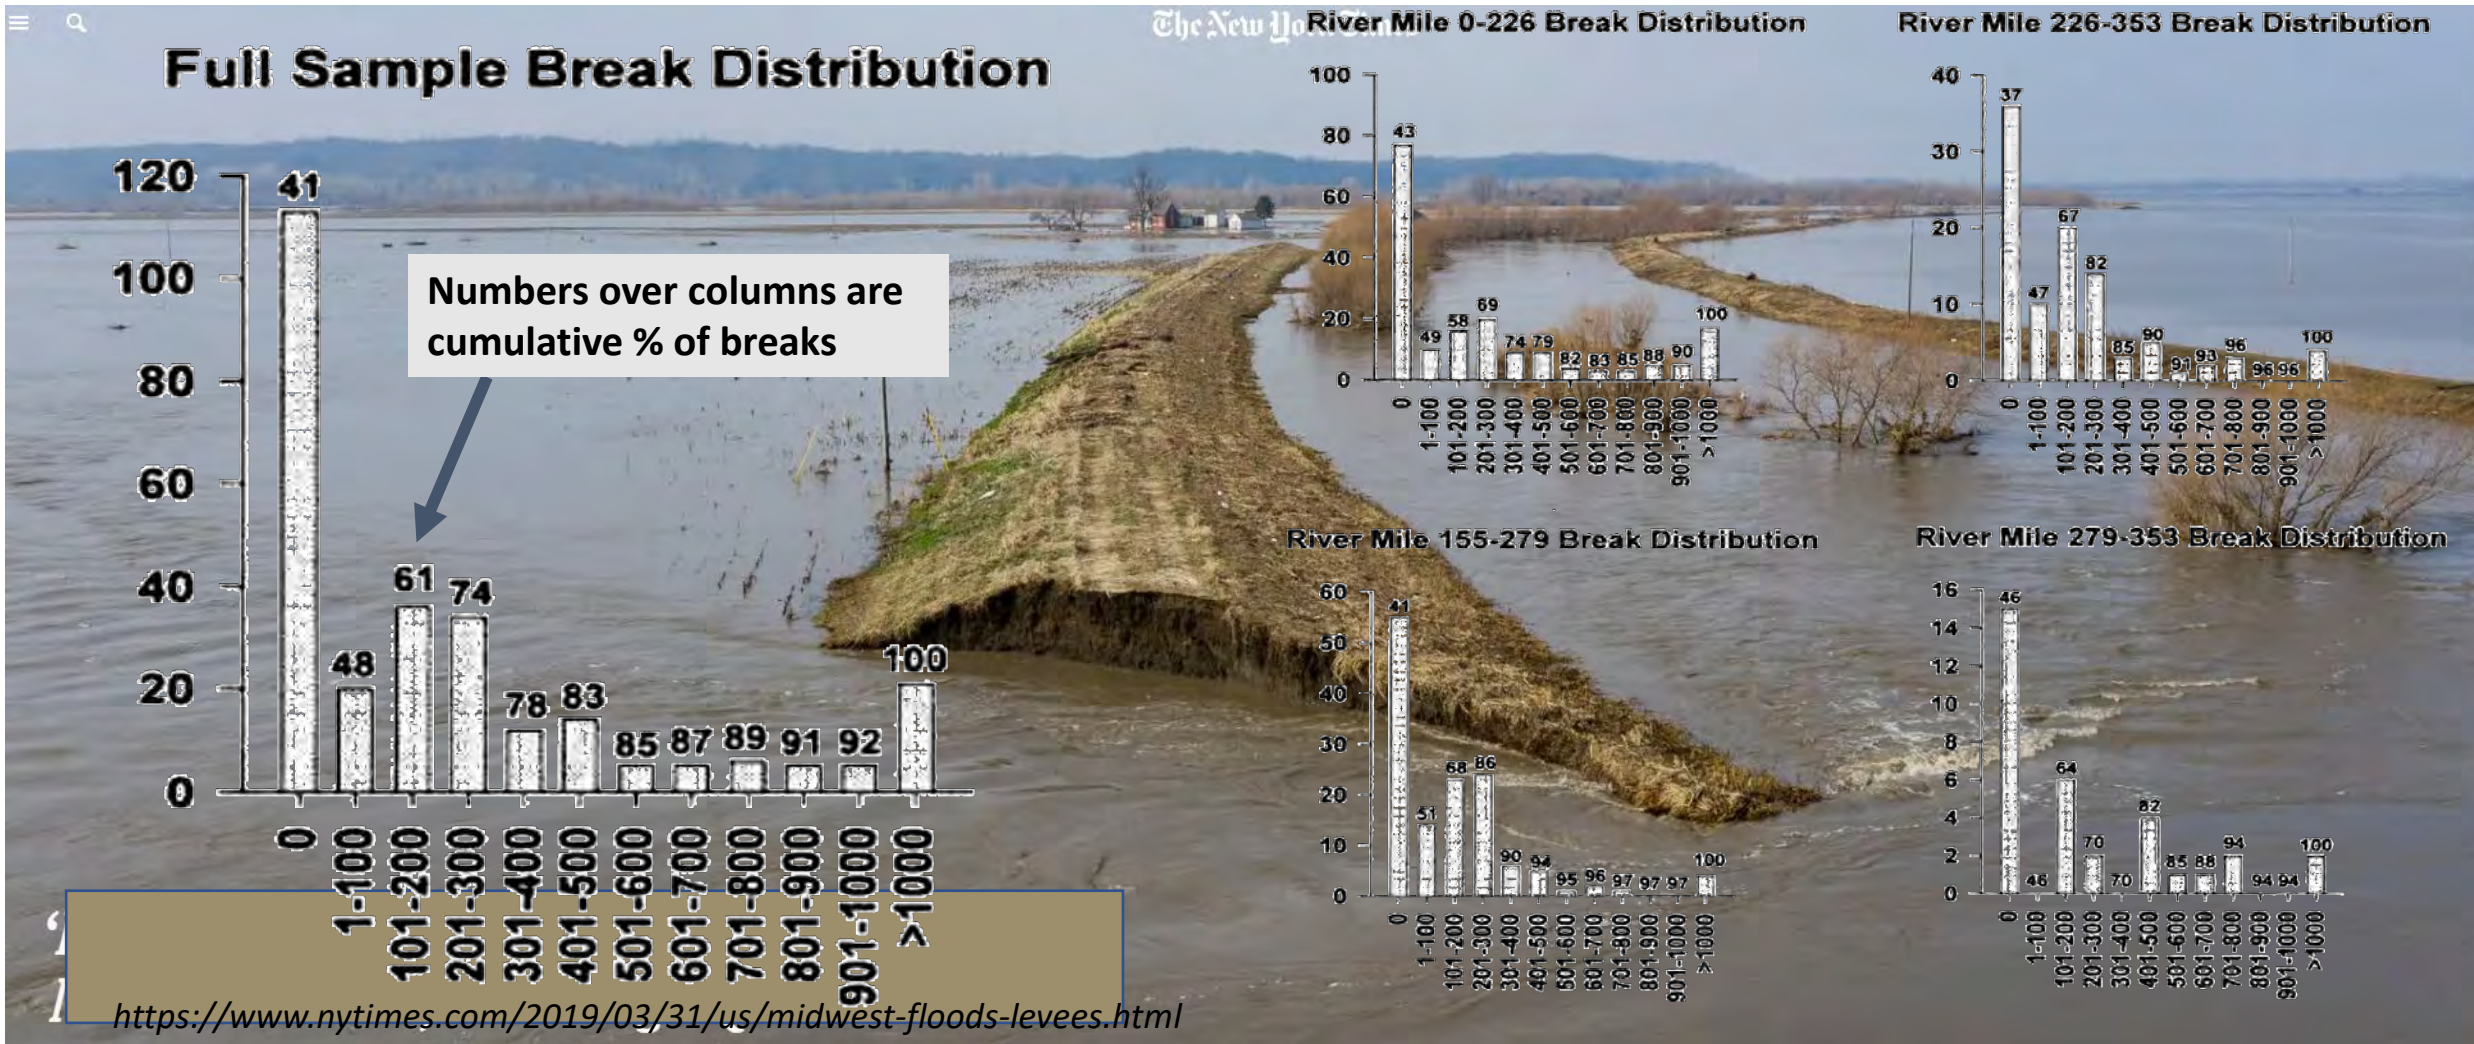
Woody corridor width and levee break frequency Missouri River, 1993 flood

Frequency and length of Missouri River levee breaks during 1993 flood were controlled by presence and width of **woody corridor**.

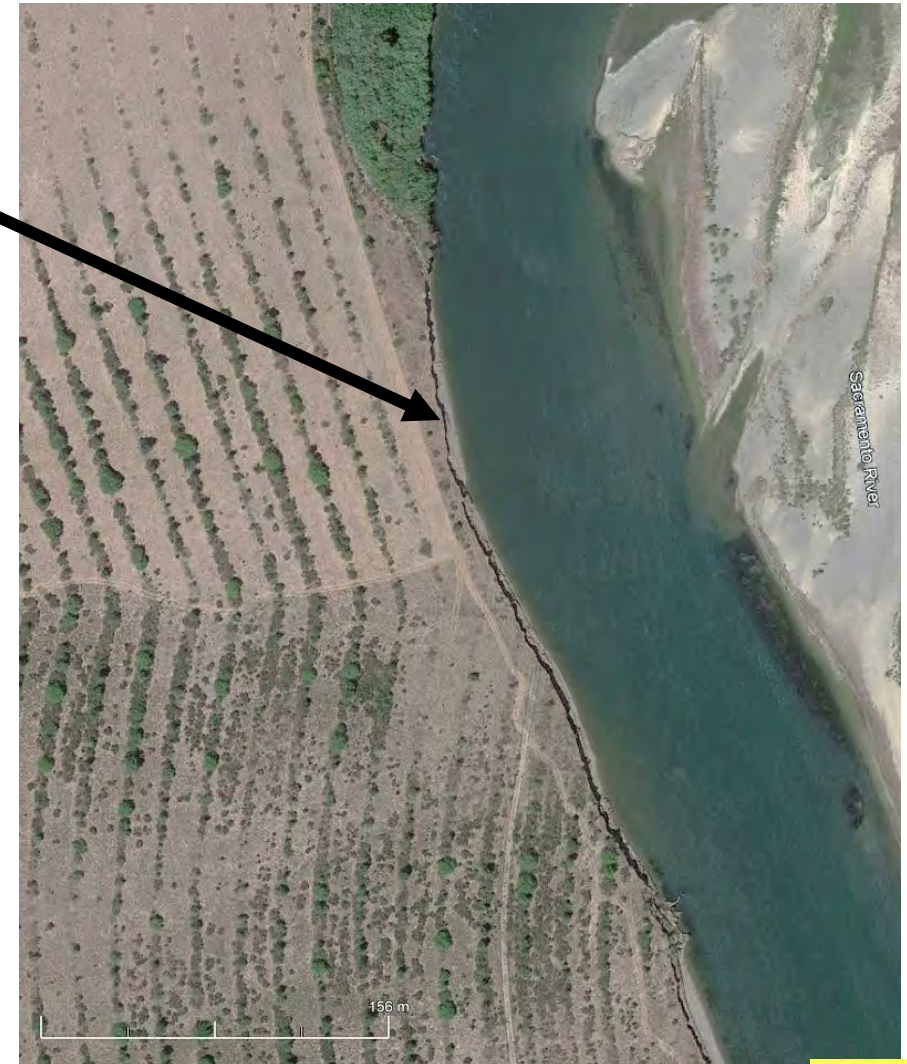
Micheli et al. (2004) found Sacramento River lateral migration rates were greatly reduced for banks with woody vegetation as opposed to agricultural land use.

Bank Erosion Rate, m/yr

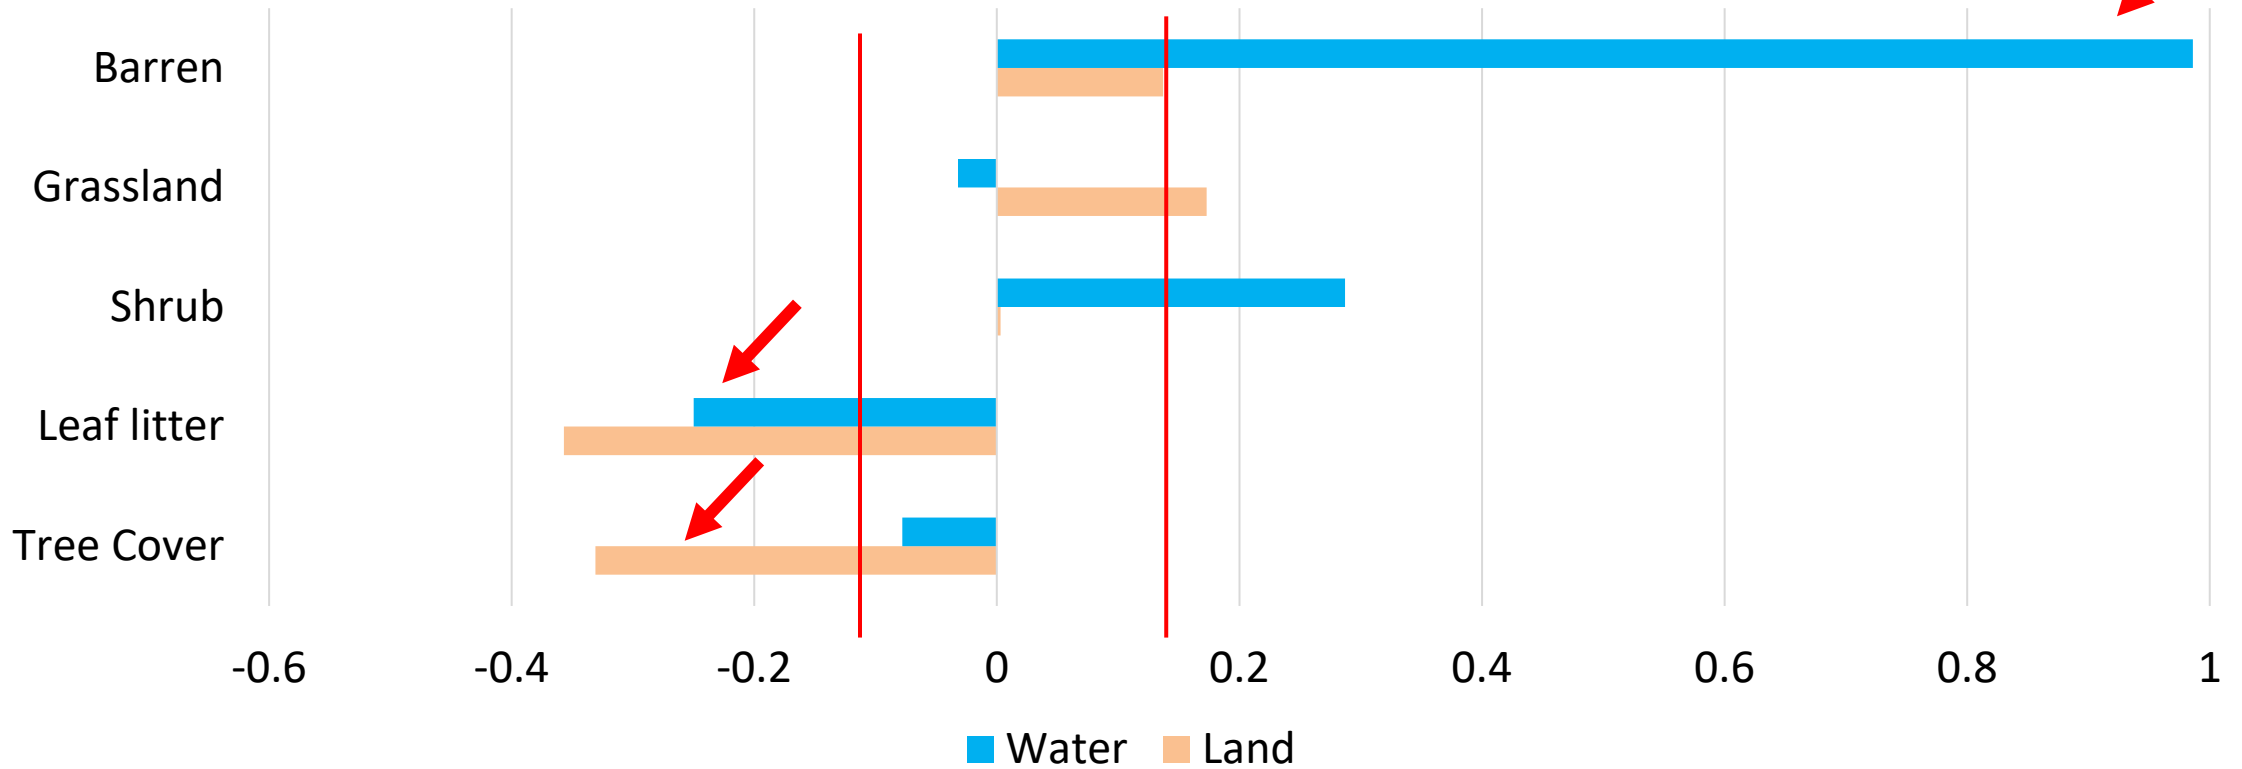
Correlation coefficient, r , between number of burrows and % of cover

- Strong association between tree cover and burrow frequency
- Hazard to levees due to **trees** is largely anecdotal and conjectural
- Hazard due to **animal burrows** is well documented in US and internationally. Animal burrows have been cited as causal factors or probable factors in numerous levee failures (Dixon 1922, Fitzgerald and Thompson 1988, Paul and Slaven 2009, Harder et al. 2009, U.S. Bureau of Reclamation 2008, Bayoumi and Meguid 2011, Harder 2012c).
