Understanding and Evaluating Ecosystem and Engineering Risks and Benefits Associated with Native Vegetation on Riverside Levees: Mild Temperate Climate of Southeast U.S.

Princeville Levee, 6105006001

Princeville and Tarboro, North Carolina

EWN Project 22-17

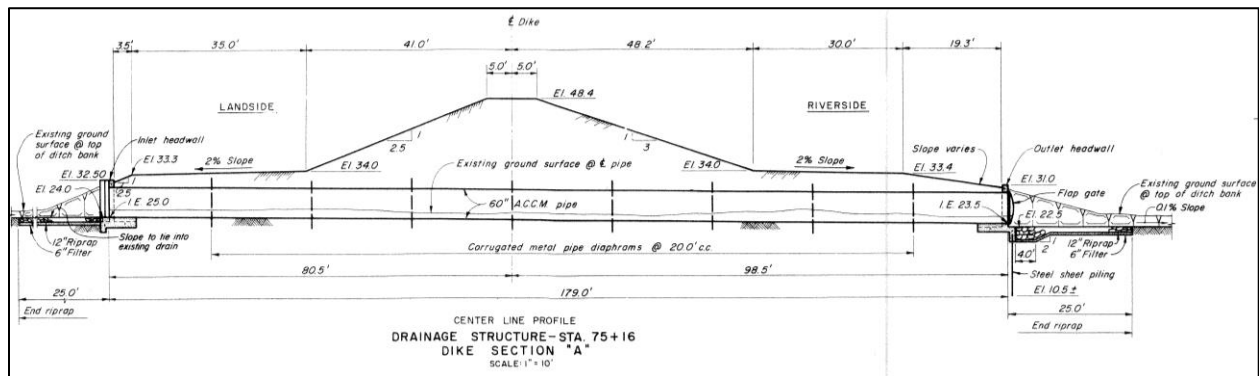
The Princeville levee system has a total length of approximately 3.33 miles and a leveed area of 1.28 square miles. It is an earthen embankment constructed from fine sand with some clay (SC) soils over a foundation of fine sand (SP) and sandy clay (CL). The underlying soils are Tarboro Loamy Sand and Wehadkee silt loam. The levee embankment has an approximate crest height of 14 ft and a width of 10 ft. The waterside slope was designed with an inclination ratio of 1:3 (vertical to horizontal). The landside slope has a ratio of approximately 1:2.5. The levee has a riverside berm that extends 30 feet riverward from the toe (Figure 2).

Figure 2. Typical section of the Princeville levee with a drainage structure.

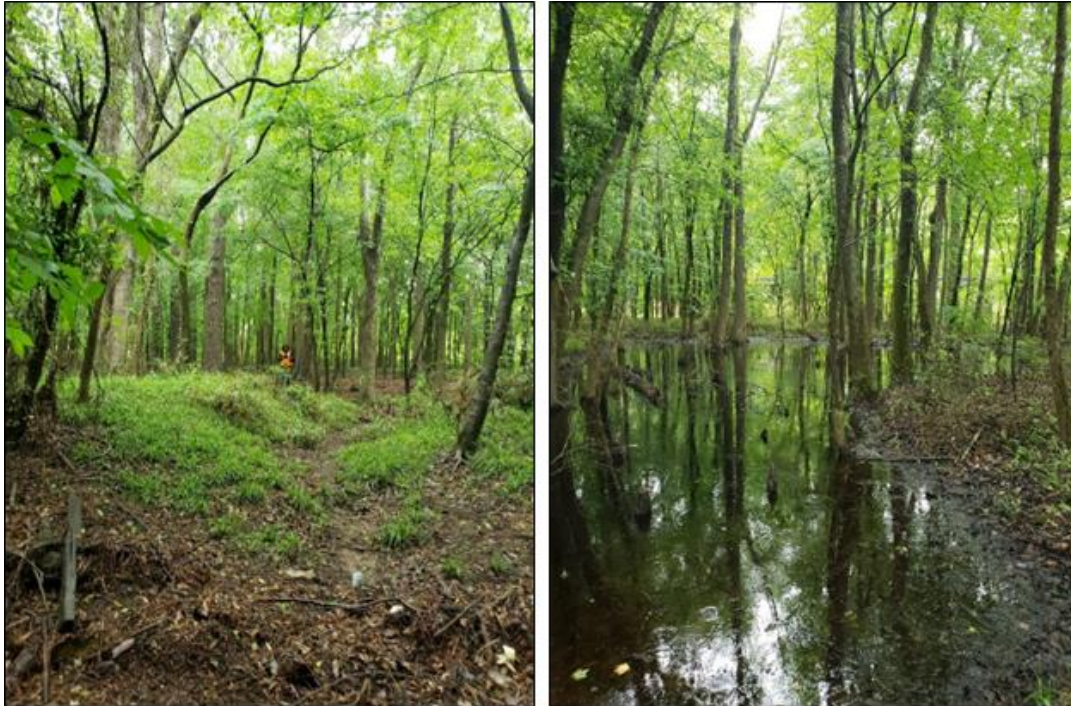
Figure 4. Photos of the Tar River within the bottomland hardwood forest.

The required riparian buffer sets the levee back from the river. The ecosystem and fluvial functions within the buffer area are intact and minimally impacted. Thus, the Tar River is set in a wide, low floodplain with low terraces that is frequently inundated (Figure 4).

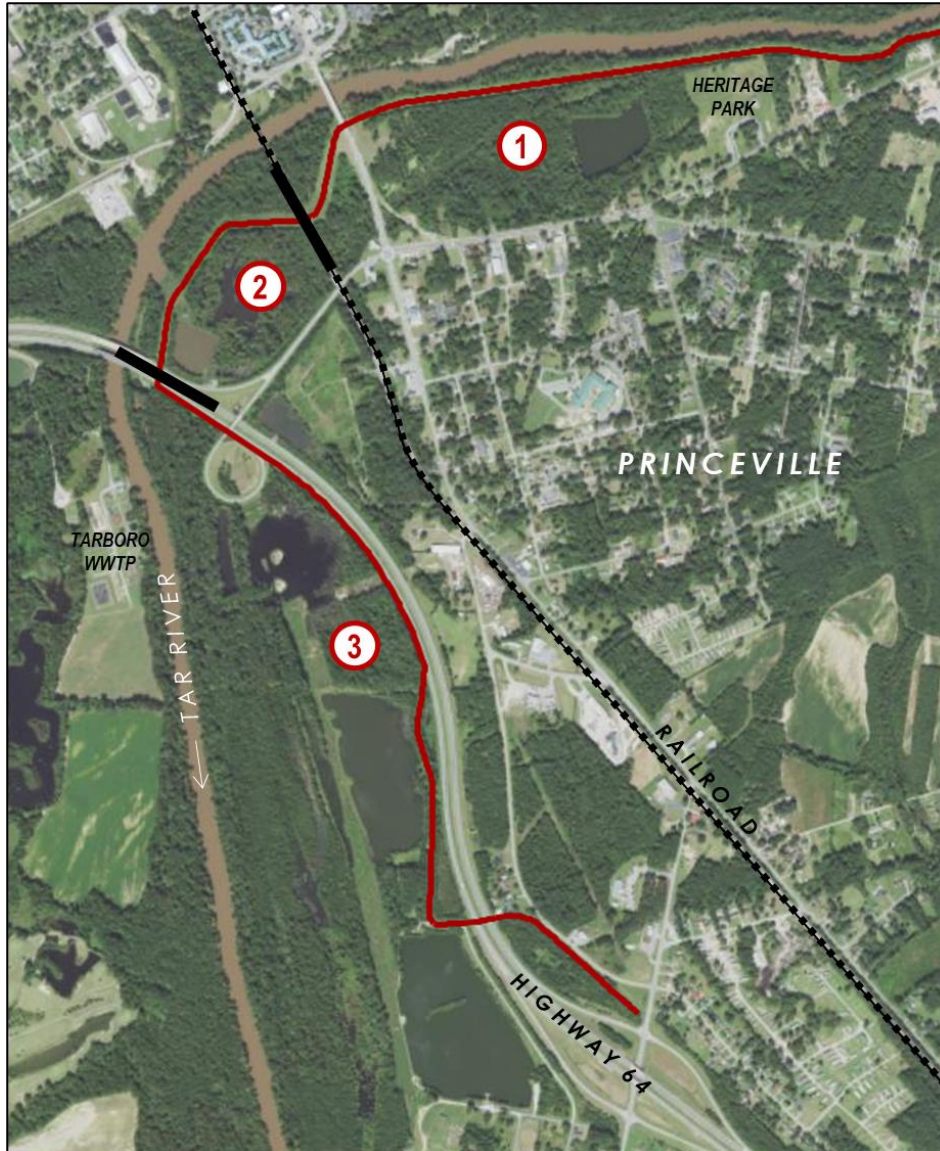
Figure 5. Princeville levee with three sections identified.

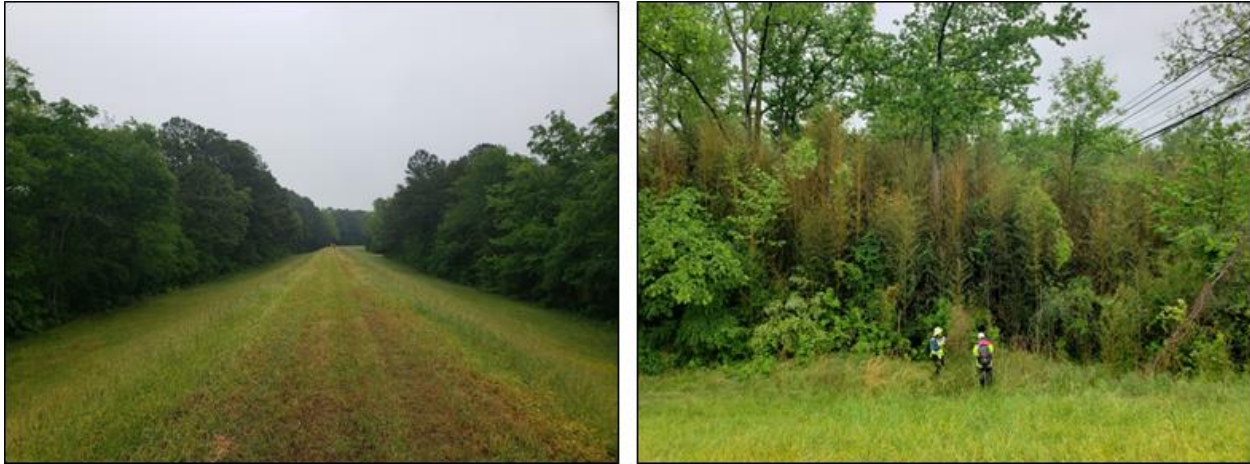
Section 1 extends over the upstream 6,537 feet of levee. All vegetation on the crown, slopes, and within 15 ft of either toe consists of non-native lawn species grasses, mowed to less than three inches (Figure 6). Several small forbs could be recognized growing within the grasses, however, they were not identifiable based on mowing disturbance. Primary herbaceous species, able to be identified, consisted of centipede grass (*Eremochloa ophiuroides*), sweet vernal grass (*Anthoxanthum odoratum*), field clover (*Trifolium campestre*), little vetch (*Vicia hirsuta*), and hare's foot clover (*Trifolium arvense*). All of these species are introduced, cosmopolitan species, that are generally associated with lawns, fallowed or abandoned fields, and vacant lots. The plants on the levee would reach a maximum height of 2-3 feet if not

mowed. The grasses may grow to near this height between mowing, particularly on the levee slopes where there is no vehicular traffic.

Figure 6. Views of the levee in Section 1. Left is looking down the levee crest. Right is looking downslope at the levee toe and riparian buffer.

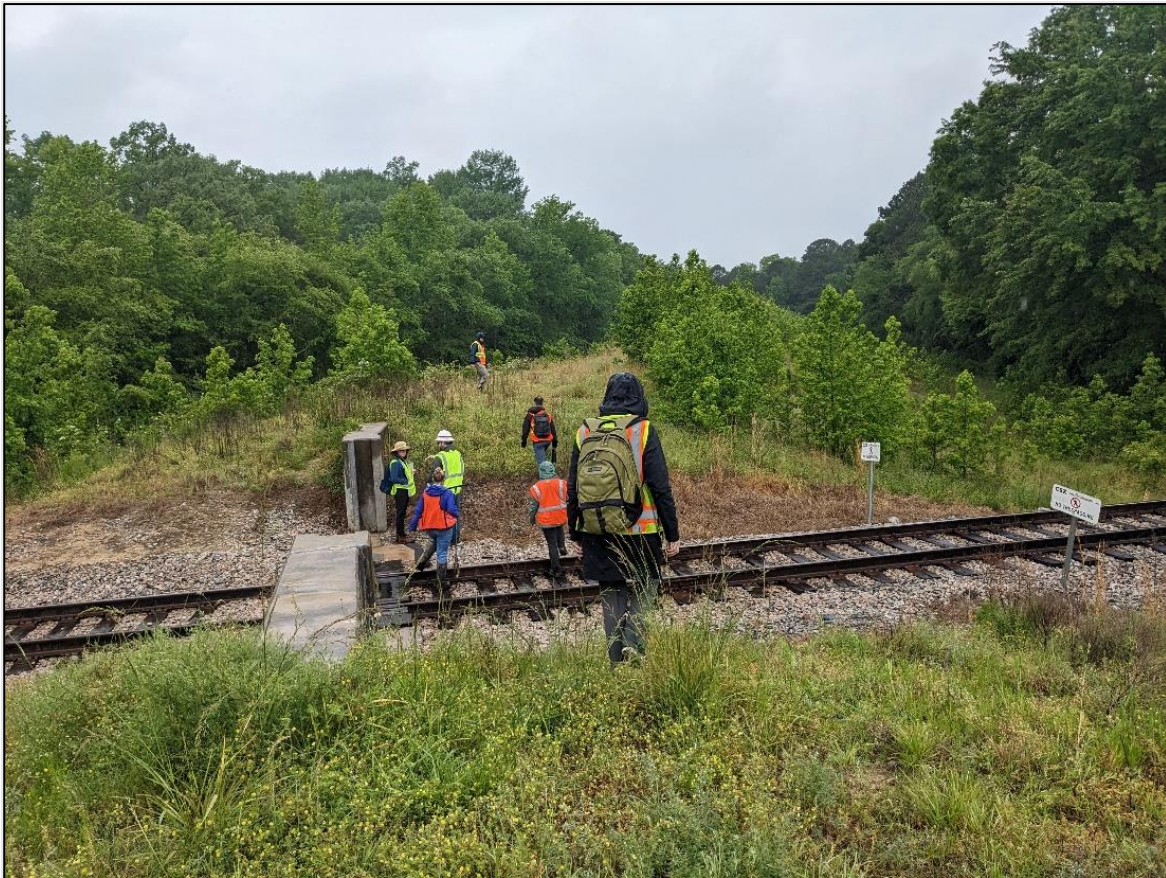
Prior to the cessation of mowing and burning, section 2 would have been the same as section 1. Because of the absence of maintenance, the levee crest and slopes have developed an uneven surface.

The vegetation on the levee has become a mix of introduced and native species. The levee had originally been seeded with the same species mix as in section 1. The reduced mowing provides the opportunity for some of the native plants to establish and for other, introduced plants to appear. It is suspected that initial seed mix contained seeds of the native species but that they had been prevented from growing in section 1 by the introduced species having a greater tolerance for repeat mowing. Without the mowing, the native plants have begun to establish and out-compete some introduced species.

Figure 7. Looking across the railroad tracks toward Section 2.

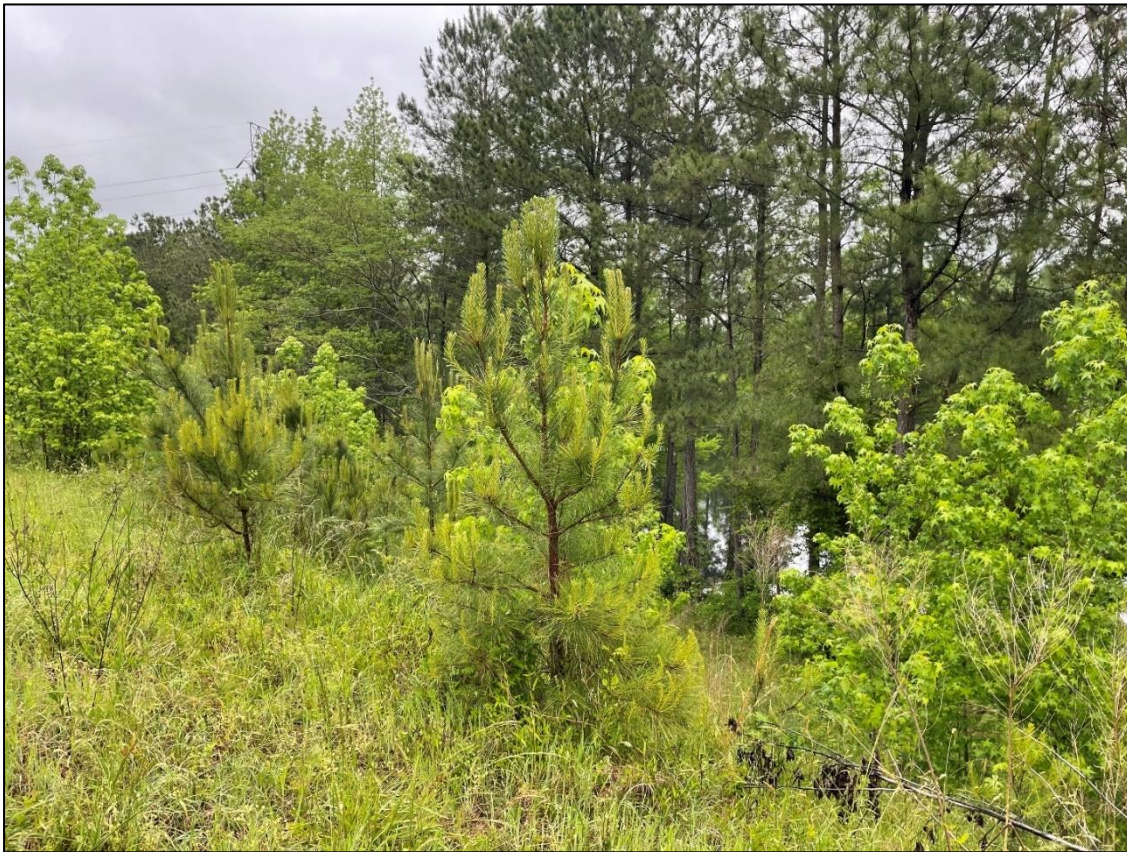
At the waterside levee toe, adjacent to the riparian buffer zone, Sweetgum and Black Birch Trees reached up to 30 feet. Loblolly Pines and Water Oaks were also growing tall along the waterside toe, indicating a possible expansion of the native riparian species where water inundation remained frequent. Both species produce acorns that may attract squirrels. The location in the riparian area where flooding is frequent would reduce the risk of burrowing.

Figure 8. Waterside slope and levee toe in Section 2.

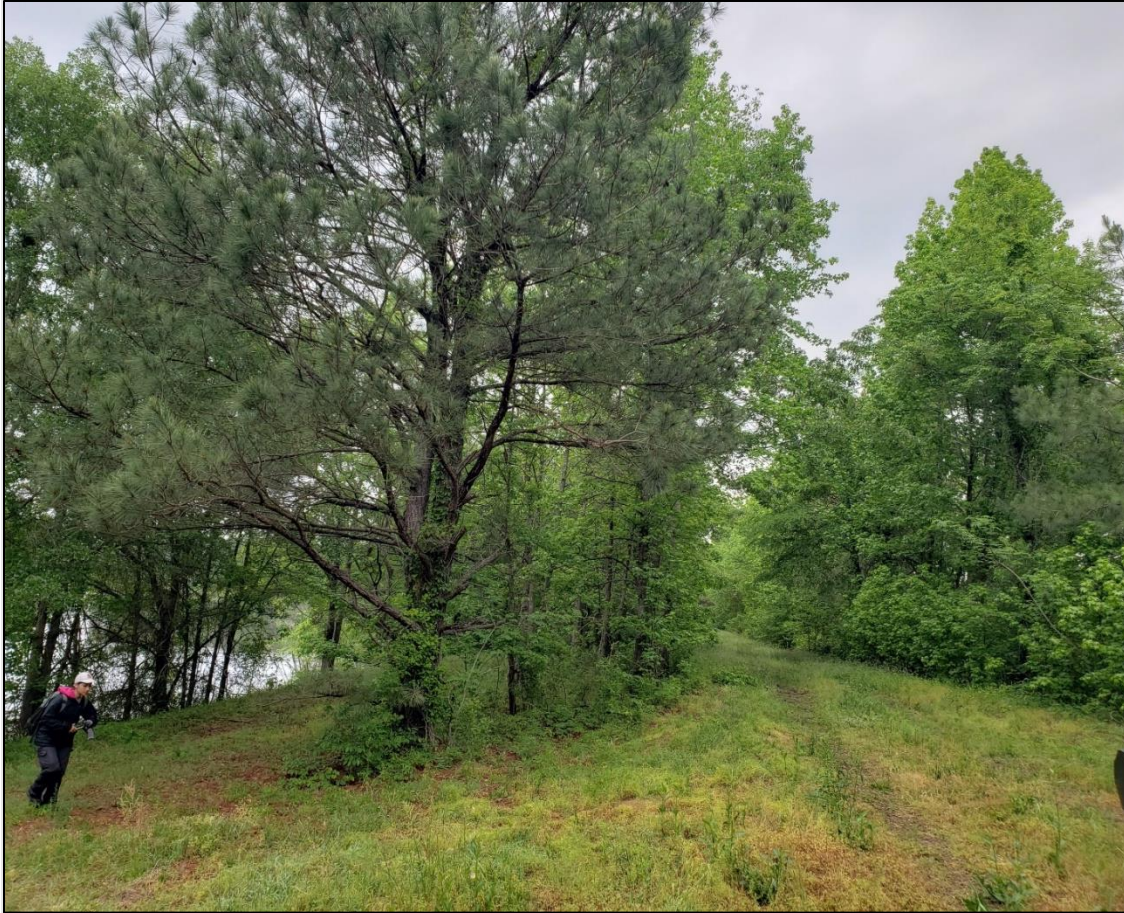
The berm slopes have not been mowed for approximately 35 years. As a result, the growth here represents a long-term succession of the vegetation on the slopes without any intervention (Figure 9). Greater vertical species diversity is immediately evident. In addition to dewberry and Virginia creeper, which are present in the expanding riparian area at the second site, the berm slopes host shining sumac (*Rhus copallinum*), which roots to approximately 10 inches and grows in full sun. This is a pioneer species, growing where there are open areas free of shading vegetation. All the species on the berm slopes attract butterflies and other pollinators. Vines provide ground cover. While native, these species may not be appropriate for every zone of an operational levee. Trumpet vine can be difficult to control and has a deep rooting depth. Common greenbrier (*Smilax rotundifolia*) vines can sprout quickly with extensive root spread. Eastern poison ivy is also growing at the site.

Trees growing in the area average 18-24 inches in DBH and are located primarily on the lower half of the slope and toes of the slope. In addition to liquidambar, Loblolly pine (*Pinus taeda*), American Beech (*Fagus grandifolia*), and Sassafras (*Sassafras albidium*) were present. These tree species are fast growing with roots in the upper two feet of soil. Most are considered pioneer species that would be replaced by slower growing and longer-lived American Beech trees in time. Figure 9 illustrates the tree growth and the influence of mowing on tree location. The trees are primarily in lines with one on the slope and one along the toe. The area between the lines is frequented by community members accessing the fishing ponds and the driving has precluded tree growth.

Figure 9. Section 3 where only the crest has been mowed for 35 years.

This site indicates what vegetation would grow and how a levee may perform if a large amount of the maintenance was removed for 35 years. As in the other two sections, there are few authorized encroachments that consist of poles with power lines. There was no evidence of sloughs, slides, erosion, or cracks in any of the sections. There was minor rutting on the berm crest that are likely from inspection vehicles and mowers. Culverts through the berm section provide drainage and they appeared to be in good condition. No animal burrows were observed by the team in this area.

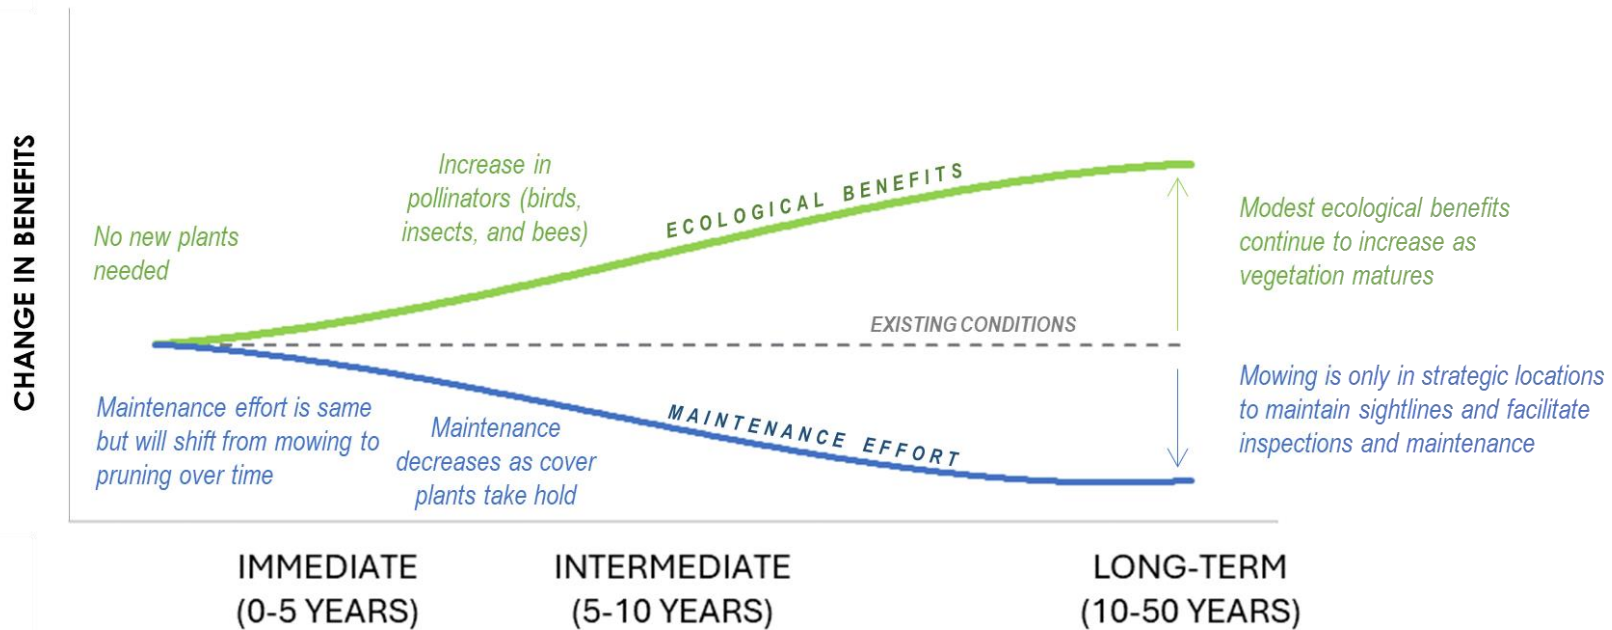
OPTION B

Adjust O&M practices to increase ecosystem benefits with minimal planting of additional species and no change to the level of flood risk management

MAINTENANCE	<ul style="list-style-type: none"> • 4 maintenance events per year • Less mowing and more pruning 	<ul style="list-style-type: none"> • Slope mowing frequency and area reduced • Mow crown once per year • Expect planting adjustments and pruning 	<ul style="list-style-type: none"> • Mowing and pruning to maintain sightlines and inspection paths • Maintenance of levee slope plants as needed
ECOSYSTEM	<ul style="list-style-type: none"> • No new plants needed • Increase in pollinators 	<ul style="list-style-type: none"> • Continue increase in pollinators • Potential increase in bioretention during floods • Maintenance costs begin to reduce 	<ul style="list-style-type: none"> • Increase ecosystem benefits to many plants, wildlife, and people • Reduced mowing

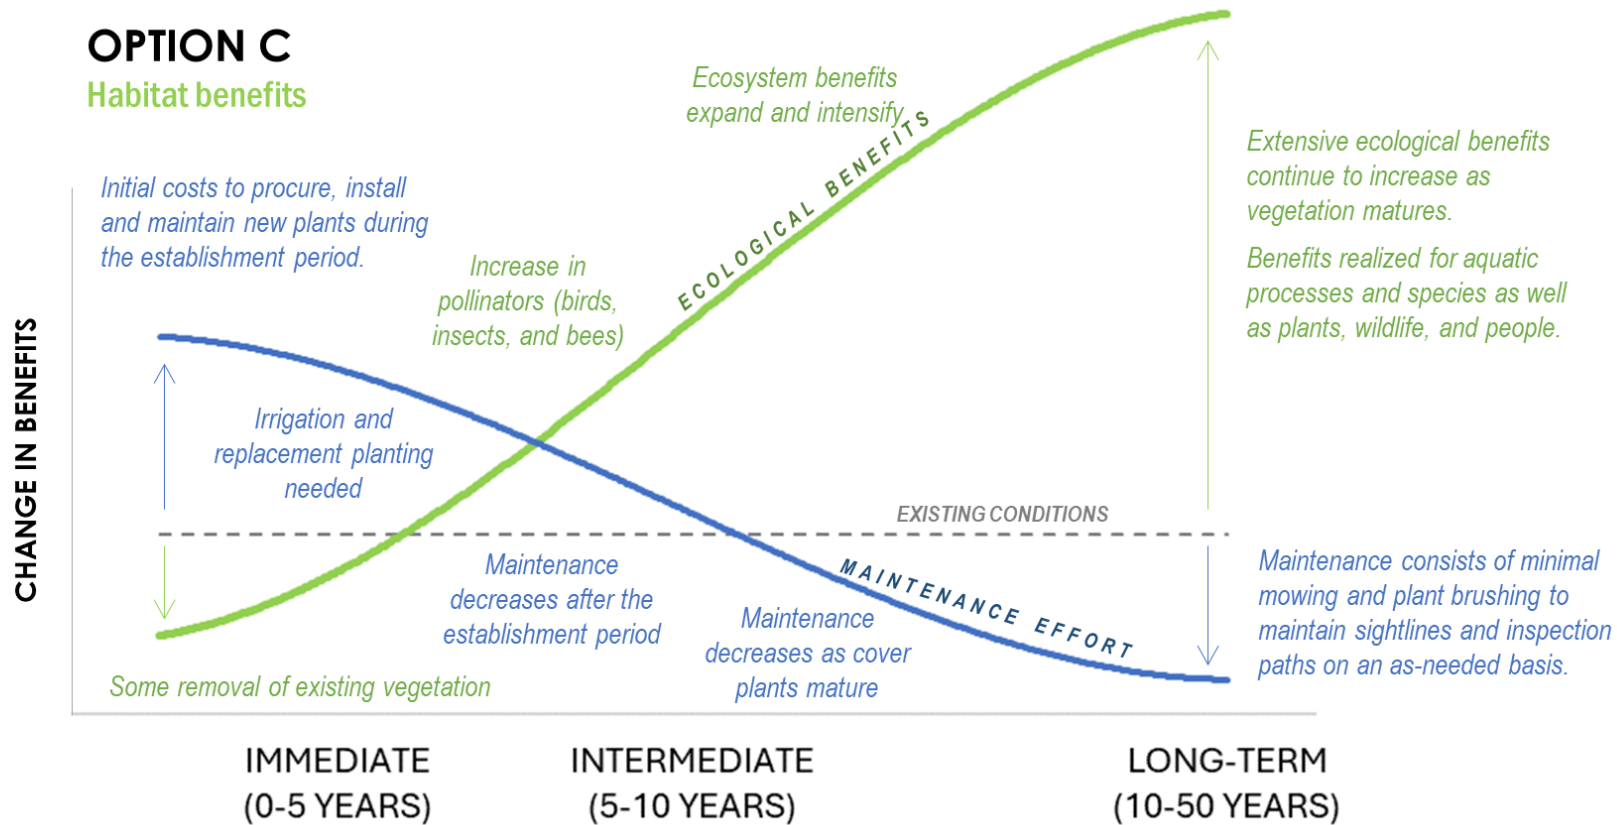
OPTION C

Maximum aquatic and terrestrial ecosystem benefits while maintaining the existing level of flood risk management

MAINTENANCE	<ul style="list-style-type: none"> Remove existing vegetation Procure new plants Establish new plantings with irrigation, maintenance, and replacements as needed 	<ul style="list-style-type: none"> Slope and crown mowing frequency and area reduced Expect pruning and cutting to maintain sightlines and inspection paths Reduce and then end irrigation 	<ul style="list-style-type: none"> Mowing and pruning to maintain sightlines and inspection paths as needed
ECOSYSTEM	<ul style="list-style-type: none"> Increase in pollinators- birds, insects, and bees Ecosystems improve over time 	<ul style="list-style-type: none"> Continue increase in pollinators Potential increase in bioretention during floods Maintenance costs begin to reduce as plants establish and invasive species are out-competed. 	<ul style="list-style-type: none"> Max ecosystem benefits aquatic processes and species as well as plants, wildlife, and people. Minimal mowing and plant brushing.

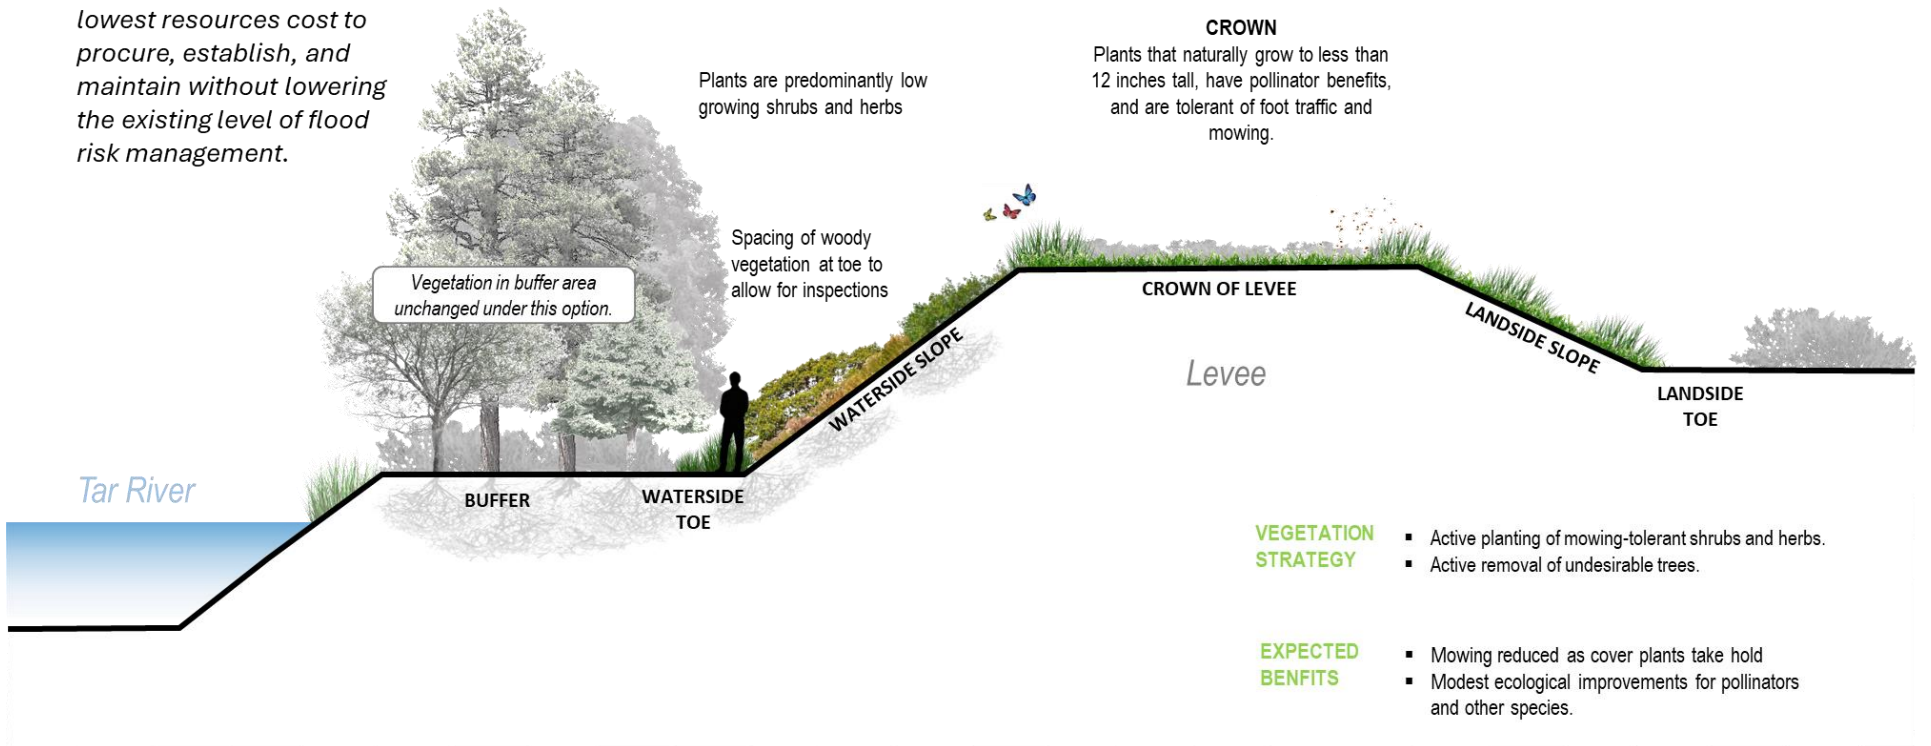
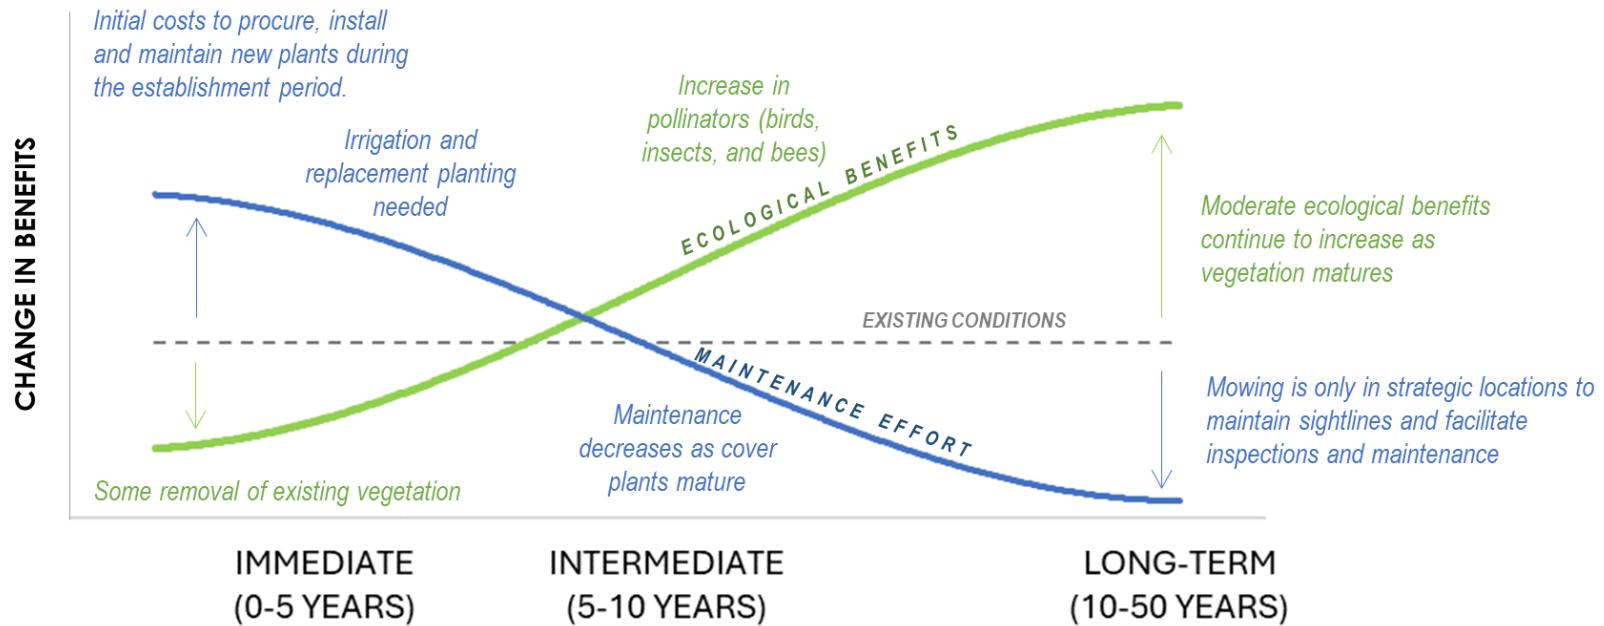
OPTION D

Planting and maintenance measures that are the lowest resources cost to procure, establish, and maintain without lowering the existing level of flood risk management.

MAINTENANCE	<ul style="list-style-type: none"> Remove existing vegetation Procure new plants Establish new plantings with irrigation, maintenance, and replacements as needed Establishing time and irrigation needs are less than in Option C 	<ul style="list-style-type: none"> Mowing reduced as cover plants take hold Reduce and then end irrigation 	<ul style="list-style-type: none"> Minimal and only as needed
ECOSYSTEM	<ul style="list-style-type: none"> Increase in pollinators- birds, insects, and bees 	<ul style="list-style-type: none"> Continue increase in pollinators Maintenance decreases as ground cover plants spread 	<ul style="list-style-type: none"> Pollinator related ecosystem benefits No mowing and minimal plant brushing.

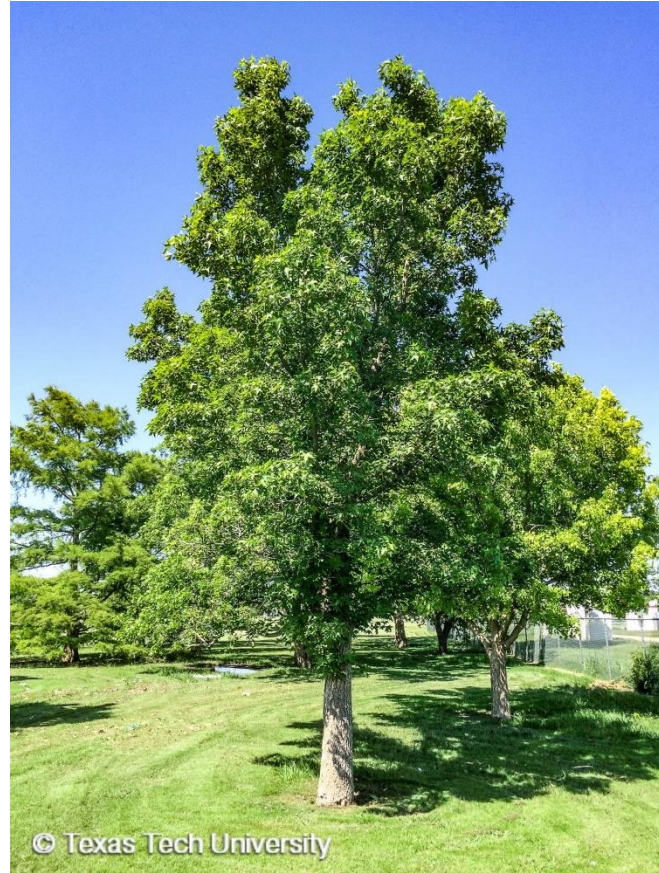
Species: Liquidamber (*Liquidambar styraciflua*)

Maximum size for the species*: 48 inches DBH, 50-150 feet tall

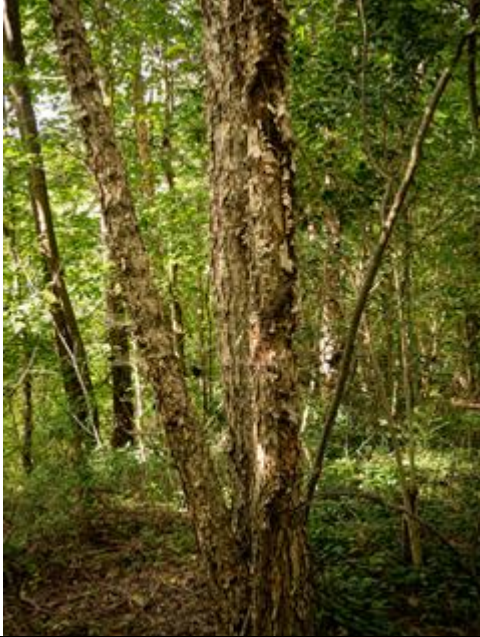
Species: Black Birch (*Betula nigra*)

Maximum size for the species*: 24-36 inches DBH, 50-80 feet tall

Location on levee profile found: Only found at the waterside toe and beyond

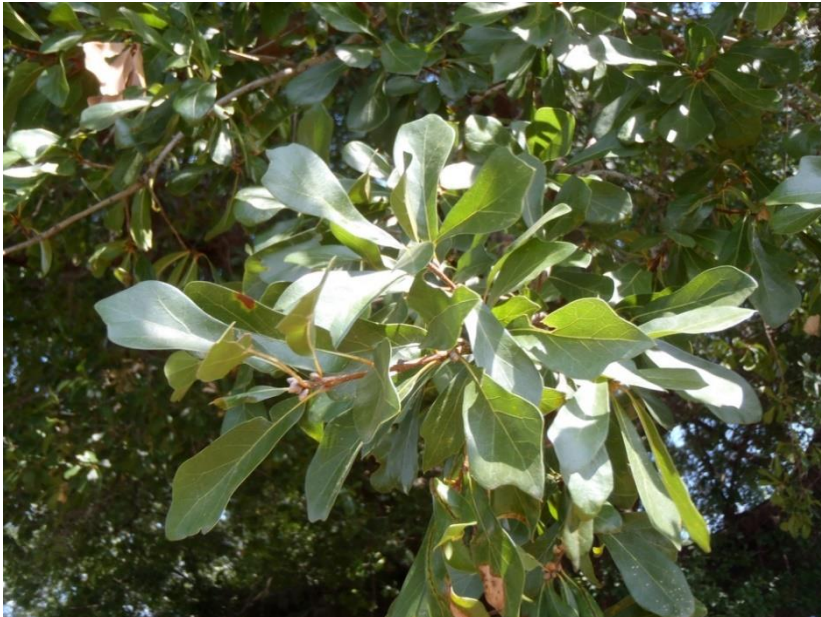
Species: Water Oak (*Quercus nigra*)

Maximum size for the species*: 24-36 inches DBH, 60-80 feet tall

Location on levee profile found: Only found at the waterside toe and beyond

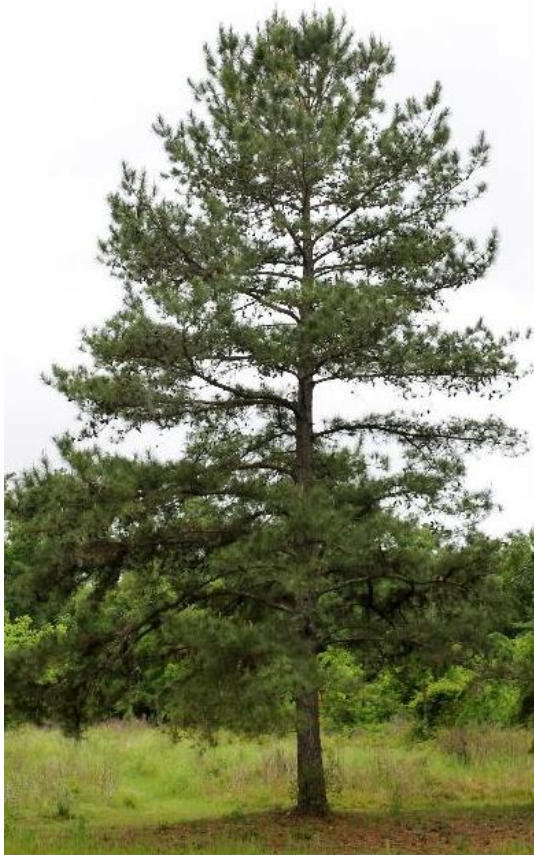
Species: Loblolly pine (*Pinus taeda*)

Maximum size for the species*: 24-30 inches DBH, 90-110 feet tall

Location on levee profile found: Found on the lower half of the waterside of the levee and on the landside toe.

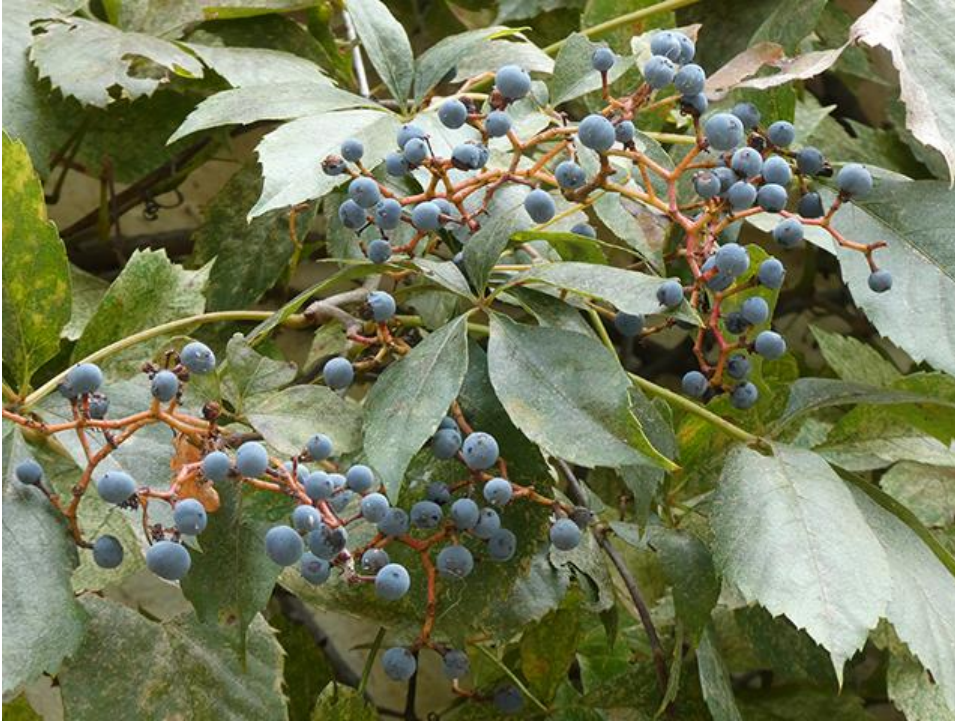
Species: Virginia Creeper (*Parthenocissus quinquefolia*)

Maximum size for the species: Climbing vine 3 to 40 feet tall; stems to 3 inches in diameter

Location on levee profile found: Found on both the land and waterside of the levee from the toe to the crown, but not on the crown.

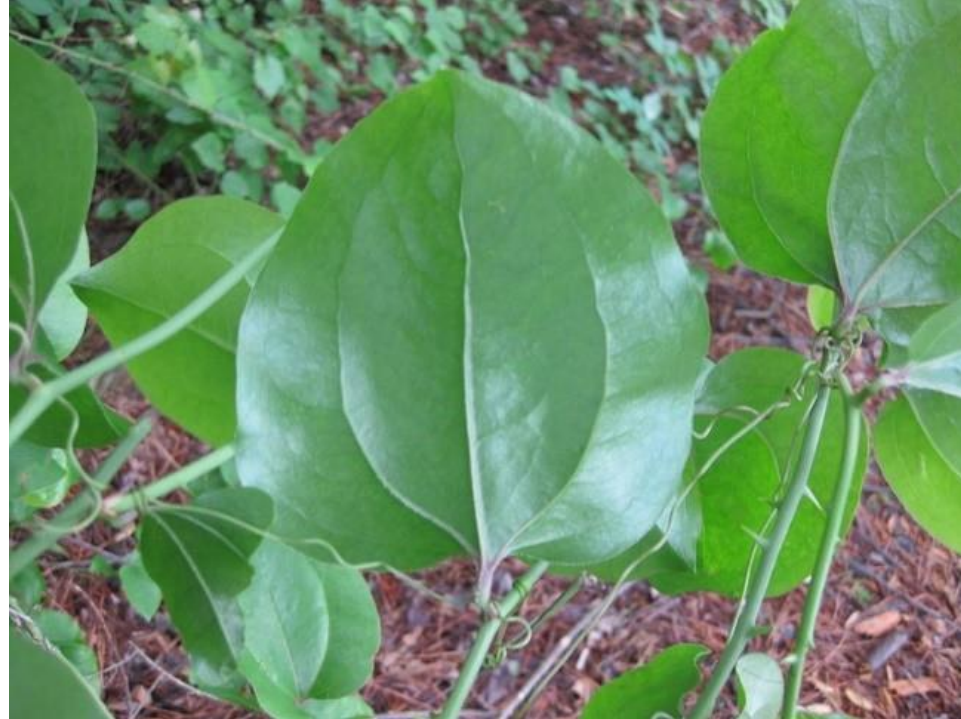
Species: Common greenbrier (*Smilax rotundifolia*)

Maximum size for the species: Less than 6 inches DBH, climbs to 20 feet.

Location on levee profile found: Located on all zones of the profile
