Tijeras Creek Watershed Restoration Project

NMED River Stewardship Program Project

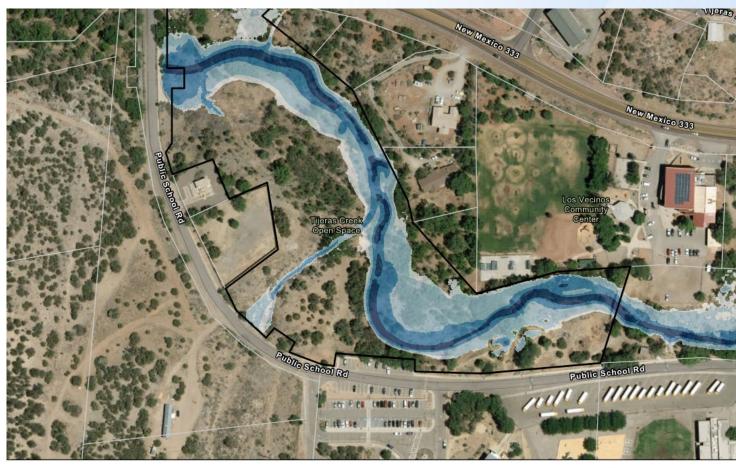
→ Project Area 1.5yr Proposed Inundation

Parcel Line 0 - 0.5 ft

0.5 - 2 ft

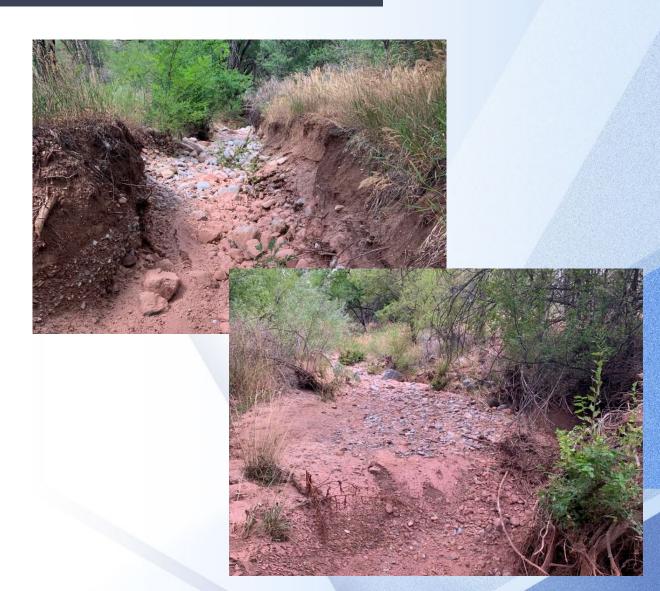
- Deteriorated riparian habitat
- Main channel
 - Incised due to watershed development
 - Hydrologically disconnected floodplain
 - Avulsed planform
- Invasive species issues
 - Siberian Elm
 - Cheat grass
 - Kochia

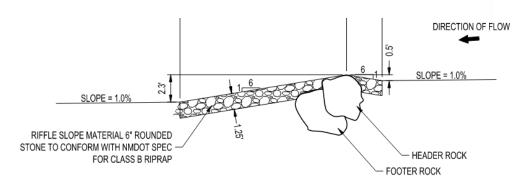
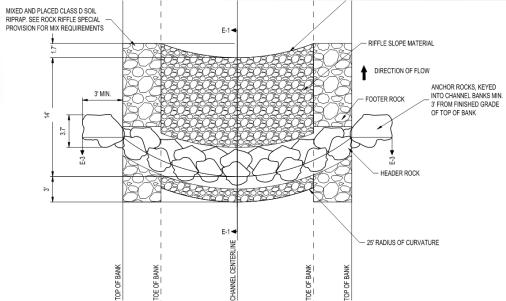
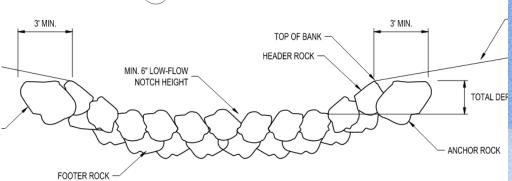
ROCK RIFFLE - FRONT SECTION VIEW AT CREST

ROCK RIFFLE - PLAN VIEW

ROCK RIFFLE - CENTERLINE PROFILE VIEW
