Natural and Nature-based Features for Roadway Crossings: A Tribal Case Study from a Fire & Flood Impacted Watershed

Nature-Based Solutions for Transportation Resilience Webinar- 30 April 2024

Case study: Santa Clara Pueblo, NM

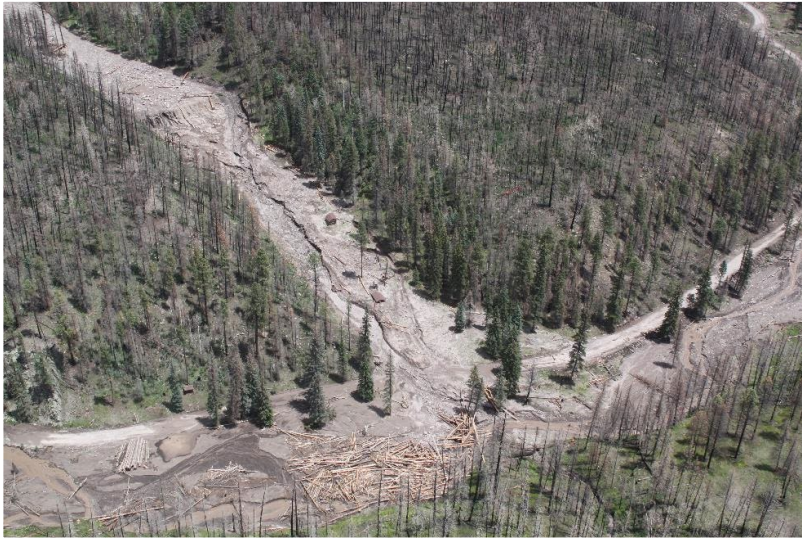
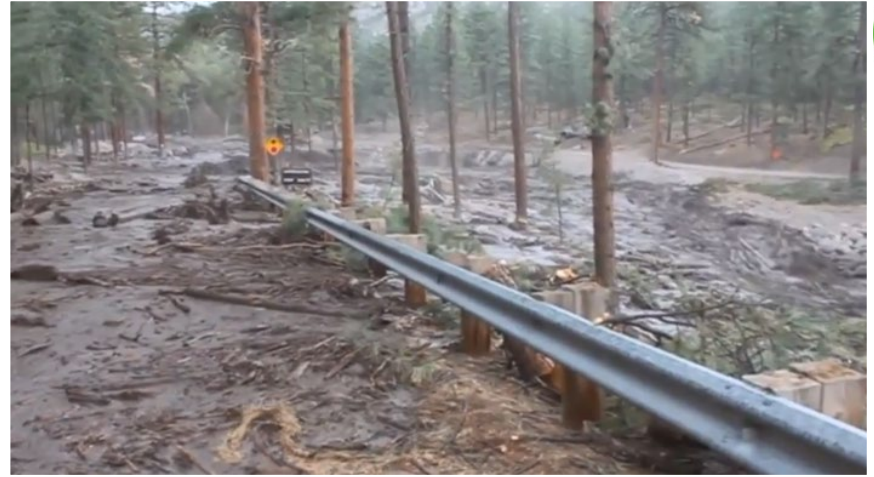
- Severe damage to roads, campgrounds and infrastructure
- Prevented tribal access 20 of last 25 years.
- Excess of \$200M in infrastructure losses

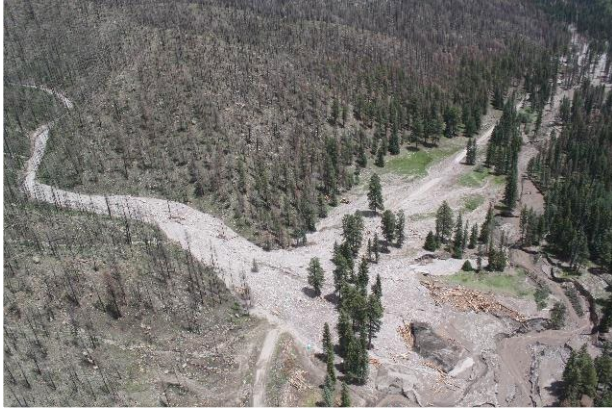
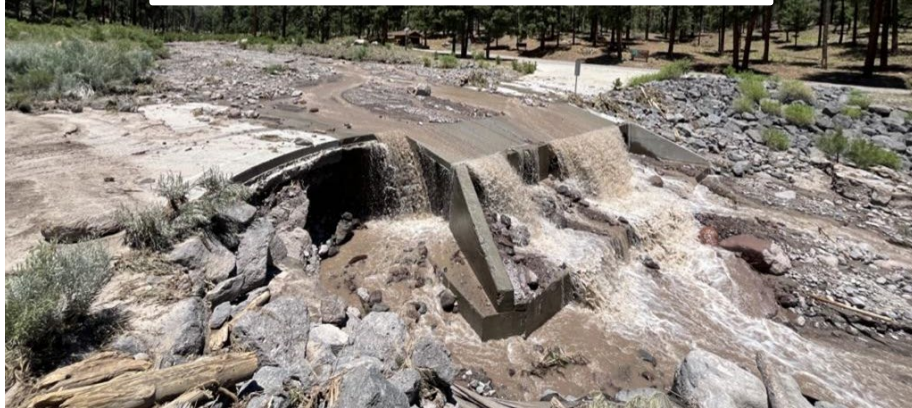
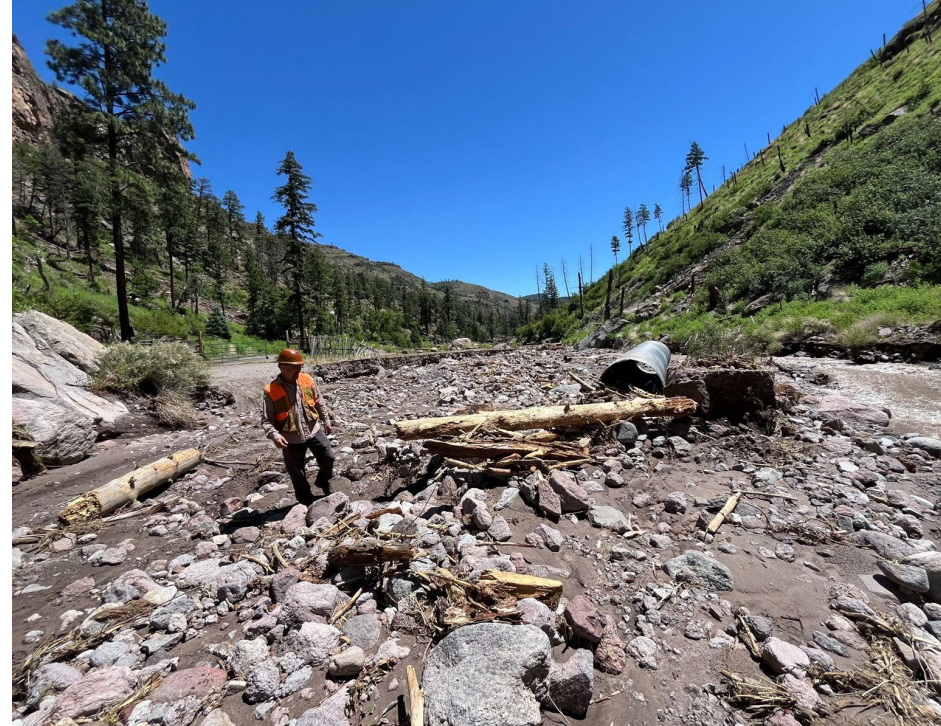
Road crossing flood impacts

7.5" precipitation event on 6/20/24

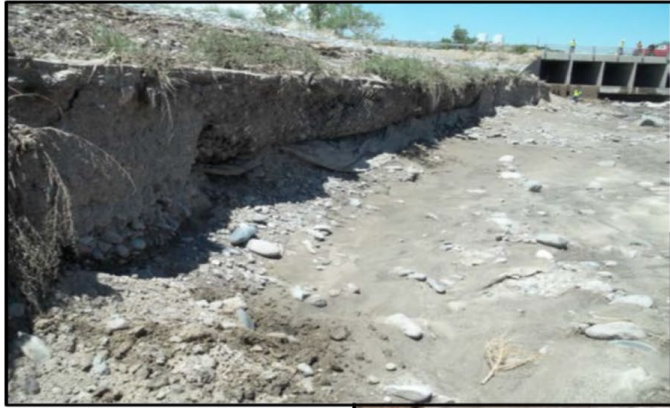
2016 box culvert extension
and scour protection

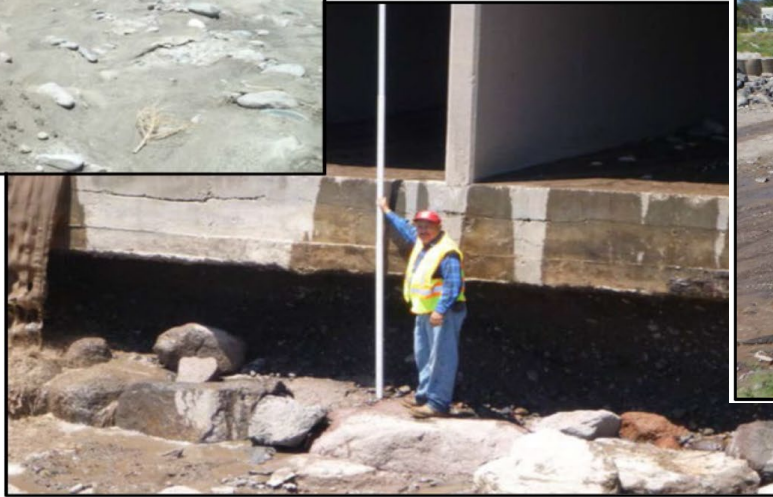
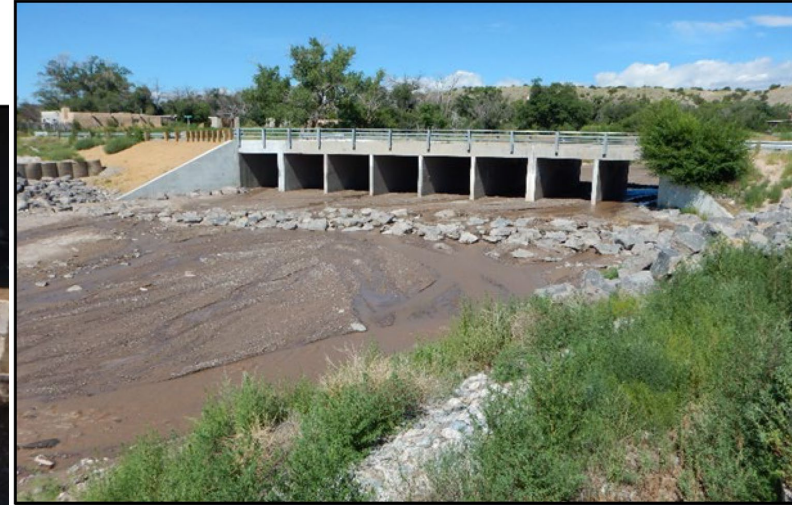
Scour from
2013
flooding

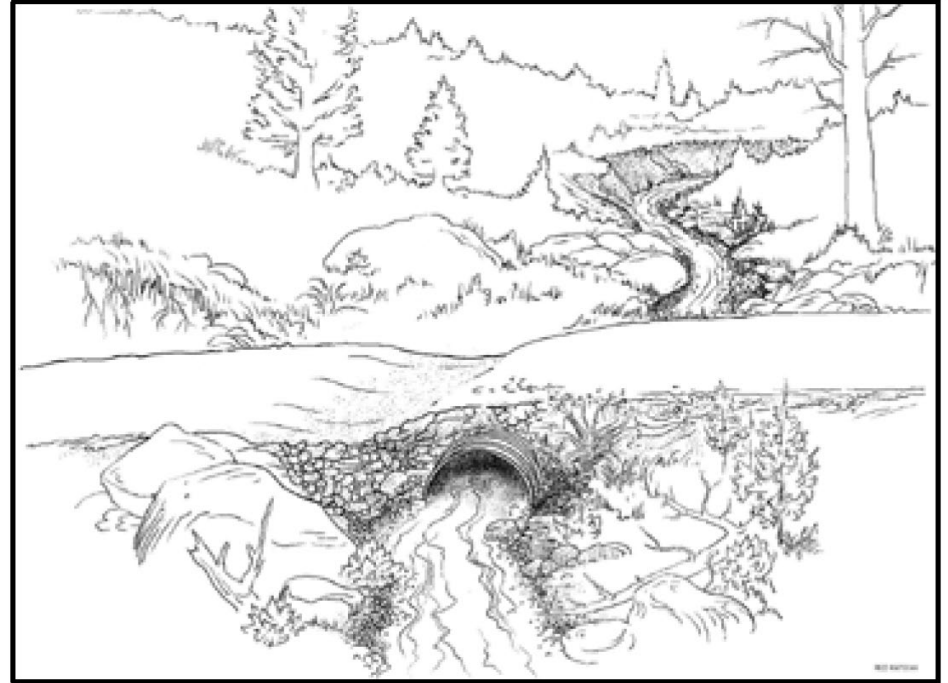
Figure 3.2 Conceptual rendering of a cylindrical culvert with an over topping roadway spillway that can integrate scour protection.

- Overtopping channels
- Inclined inlet headwalls for debris catchment
- Ramps to connect grade (natural or structural)
- Perched culverts for conveyance, and wildlife

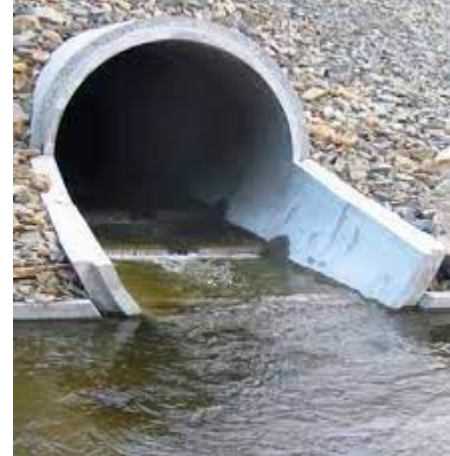
Culvert baffles <https://www.ats-environmental.com/>

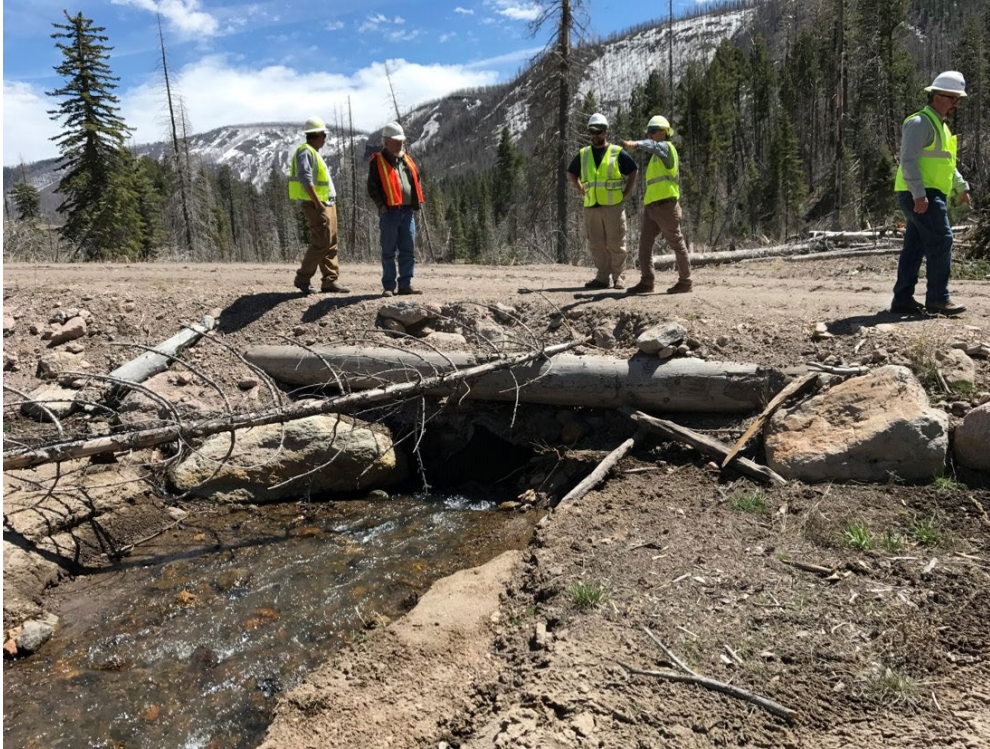
Site 1: P'opii Khanu road crossing

Confined single culvert

- 48" x 20' CMP
- Prone to clogging
- Past useful life
- No inlet/outlet protection
- Limited conveyance
- Barrier to fish passage
- Adjacent wetlands & springs
- Culturally sensitive area

As a result, we opted for an arch-type culvert upgrade and extensive stream restoration for this site.

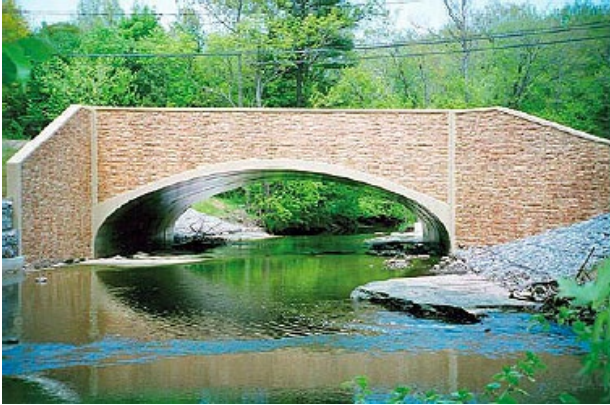
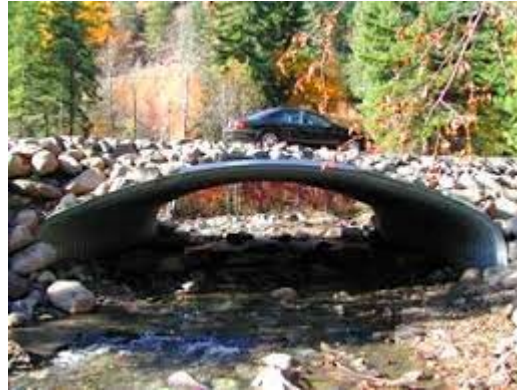
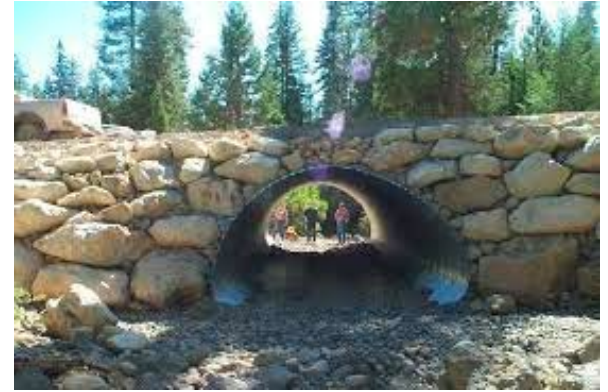
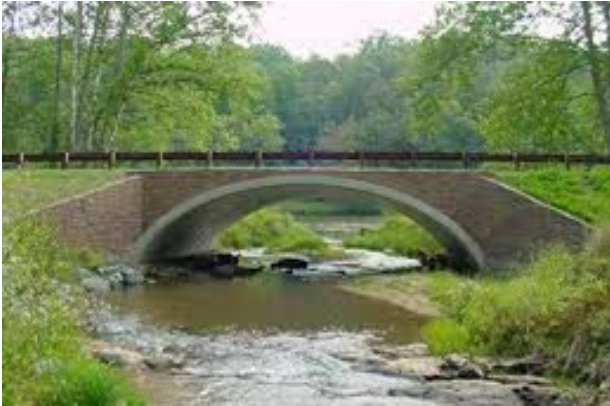
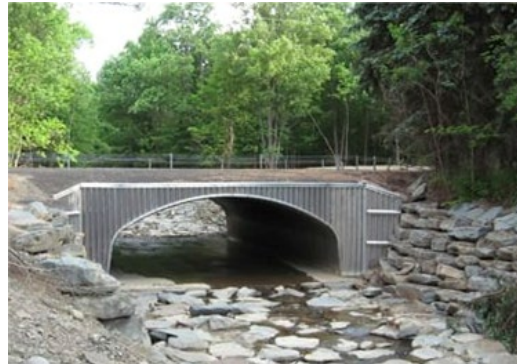
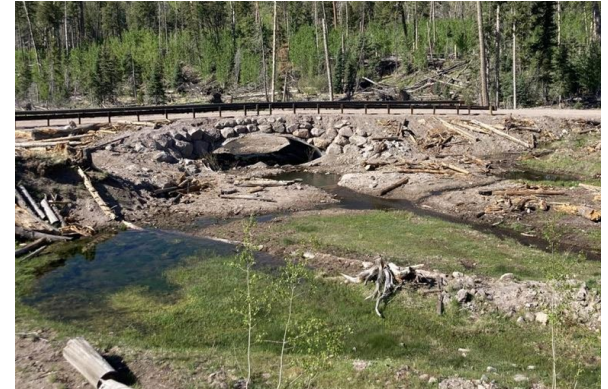
Arch type, natural-bottom culverts

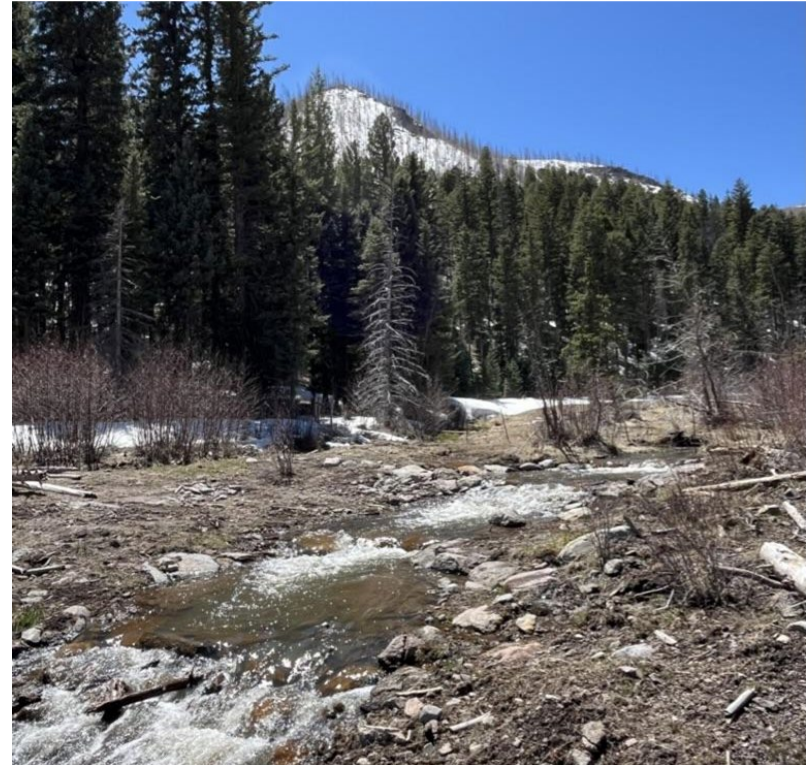
NNBF: Cross vanes for grade control

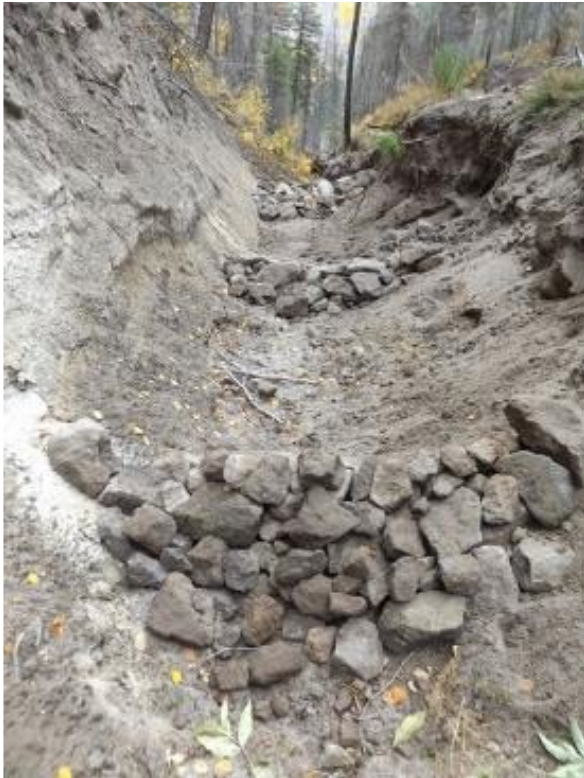
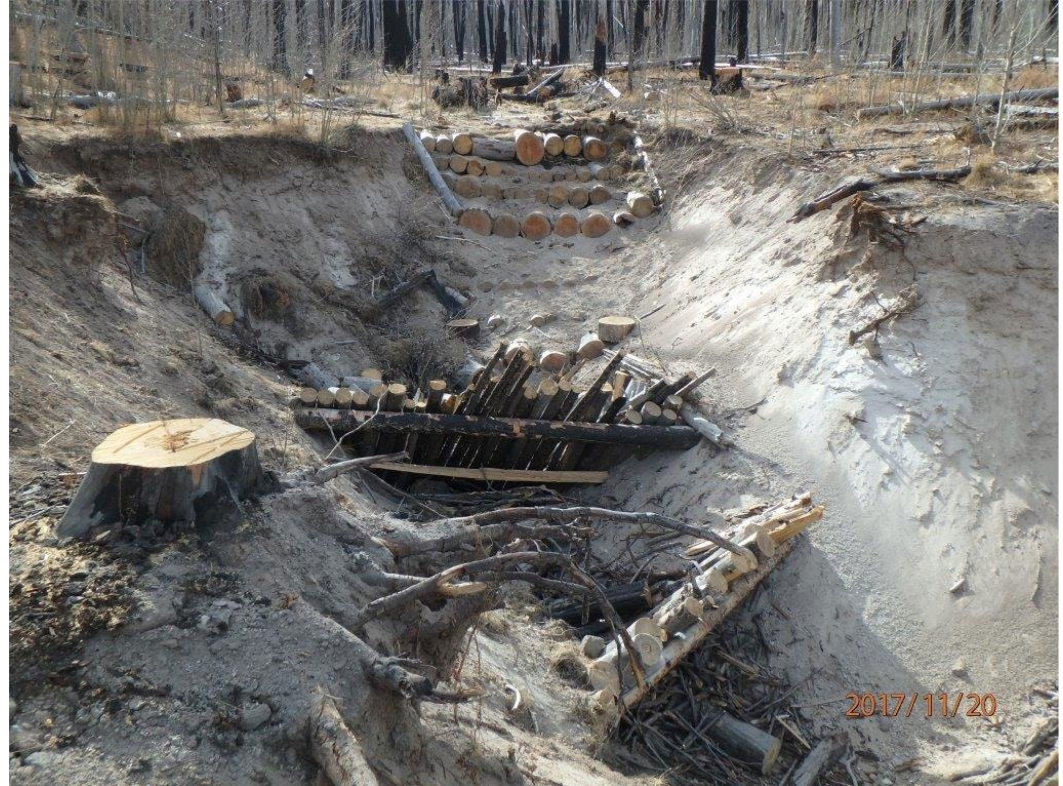
NNBF's for grade control

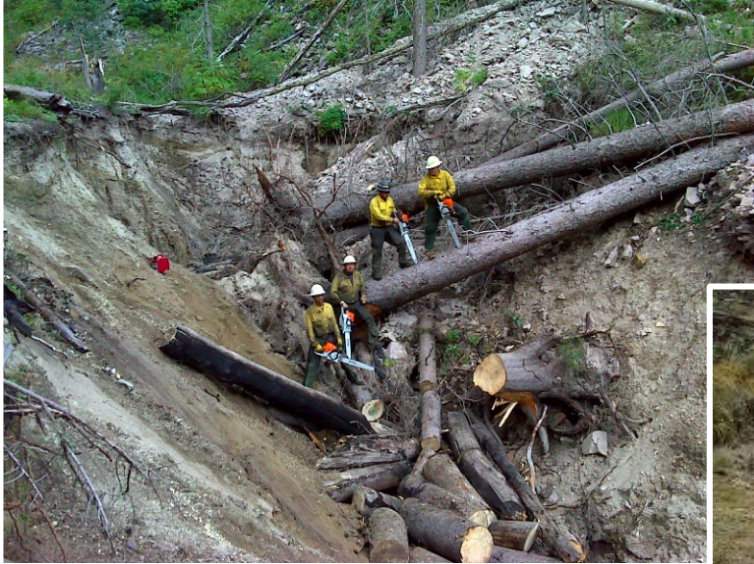
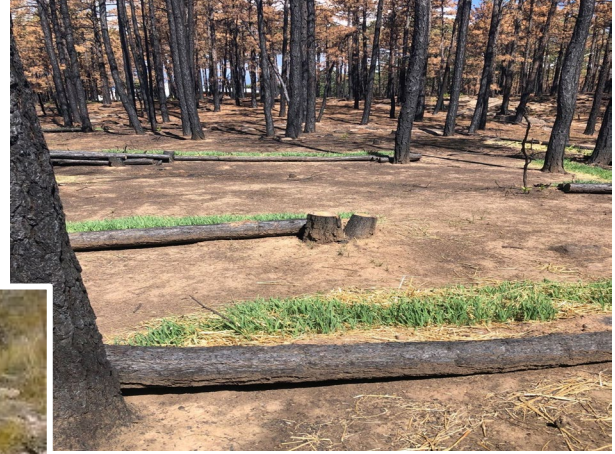
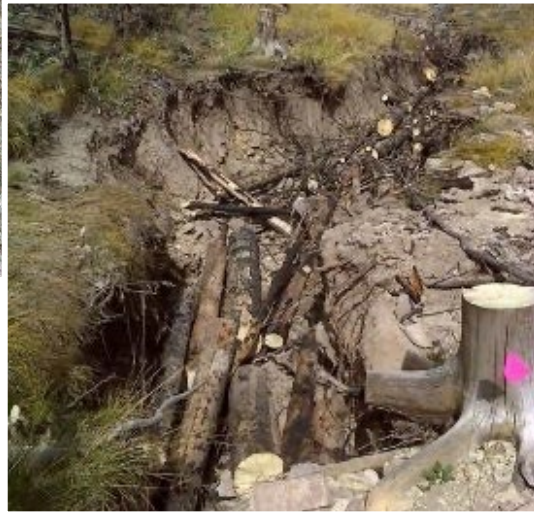
NNBF's for sediment management

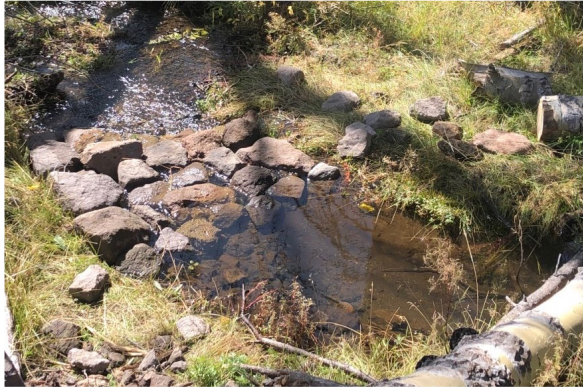
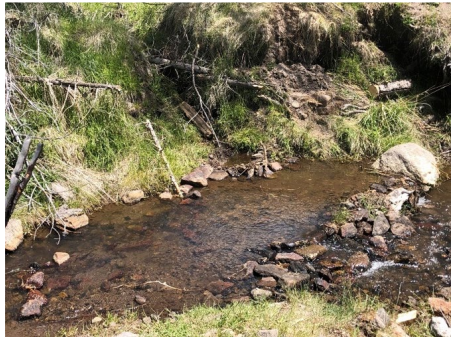
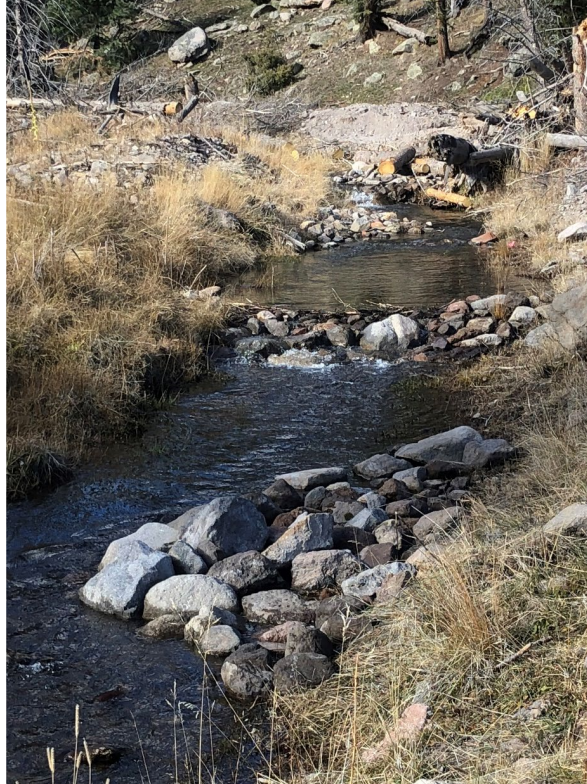
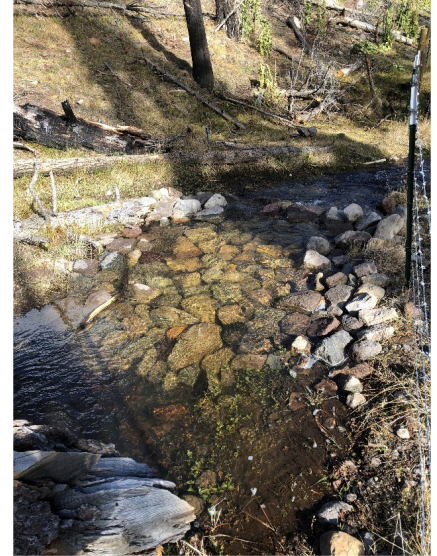
Hand-built NNBF's for stream restoration

One-rock dams, baffles, run-downs

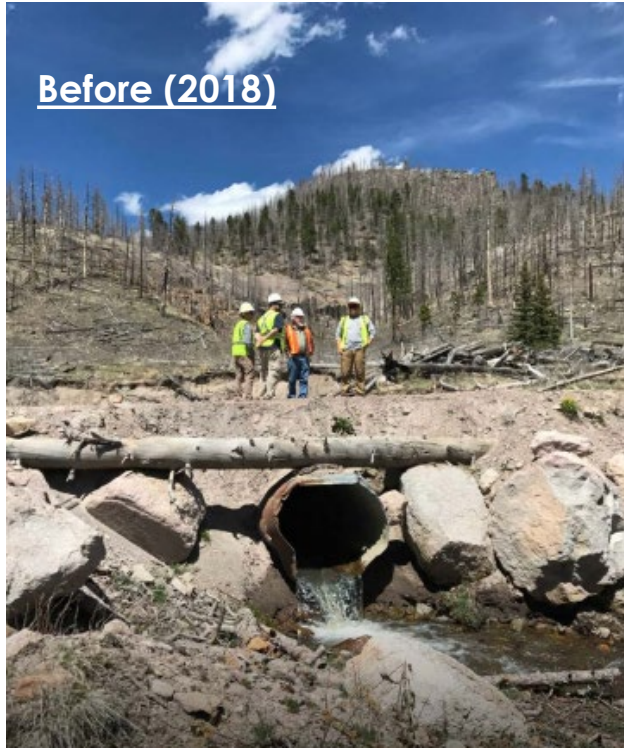
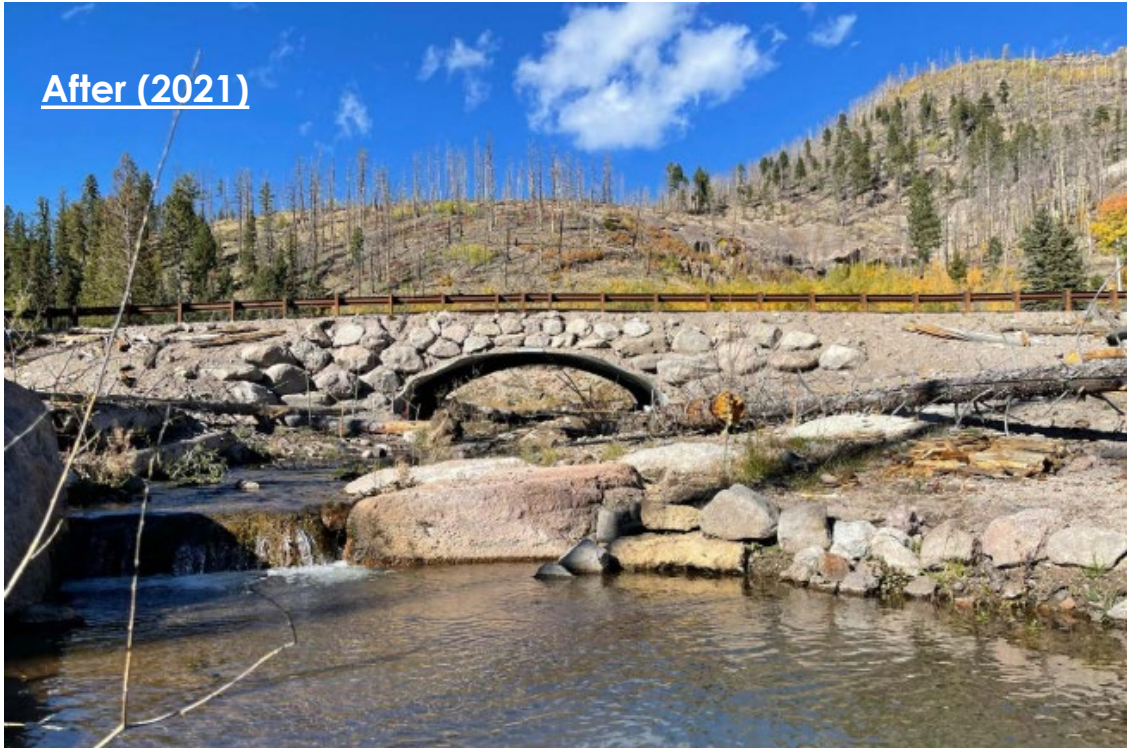
Site 1 crossing upgrade

- Natural bottom arch culvert with stacked stone headwalls
- Removed fish barrier

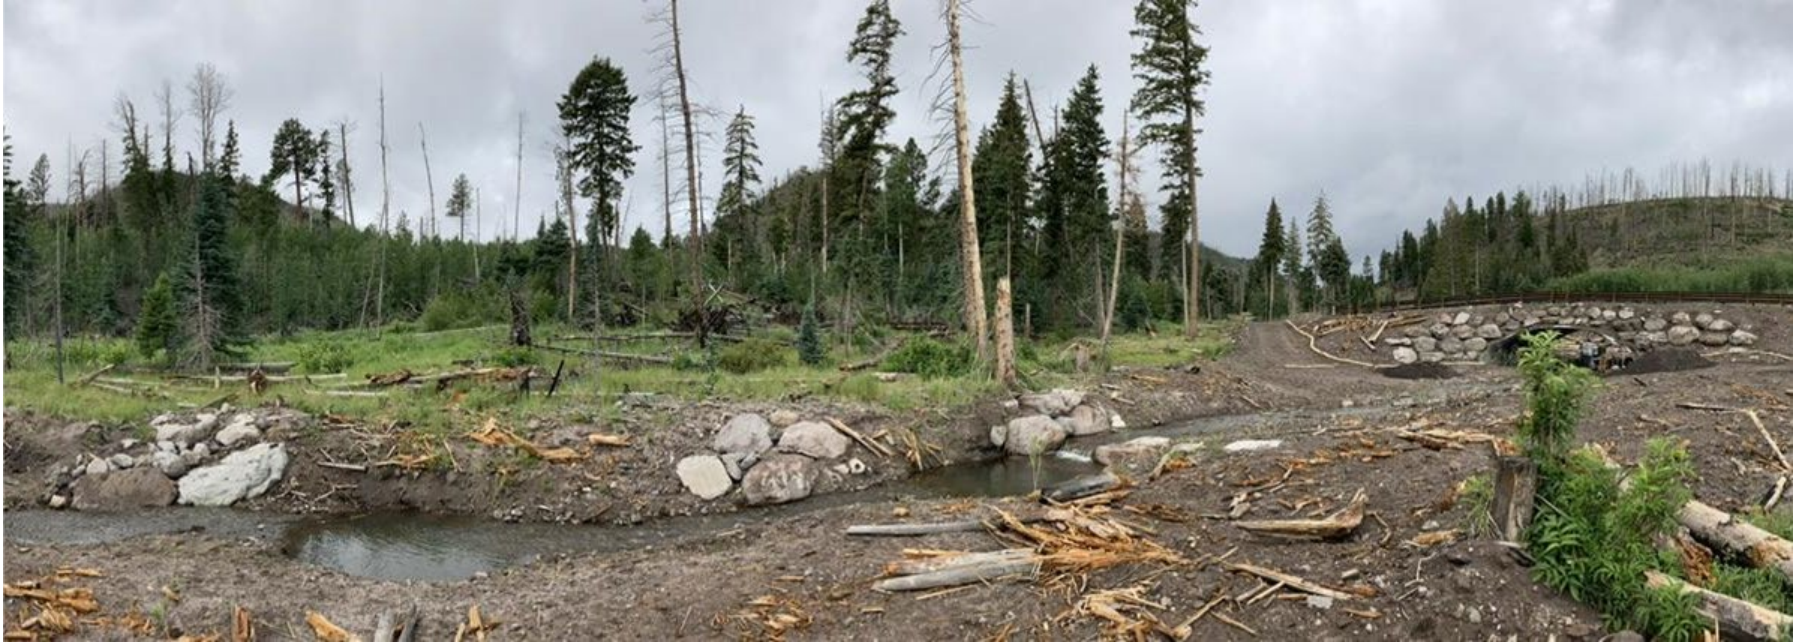
Creek restoration downstream of crossing upgrade

FEMA HMGP 2021 Flood mitigation and creek restoration project, Santa Clara Pueblo, NM

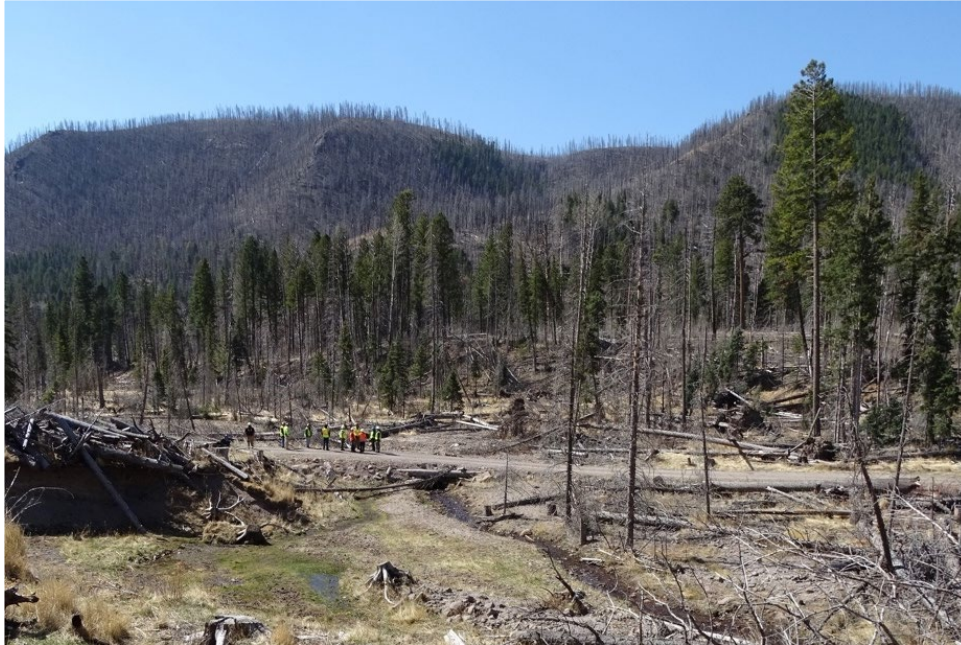
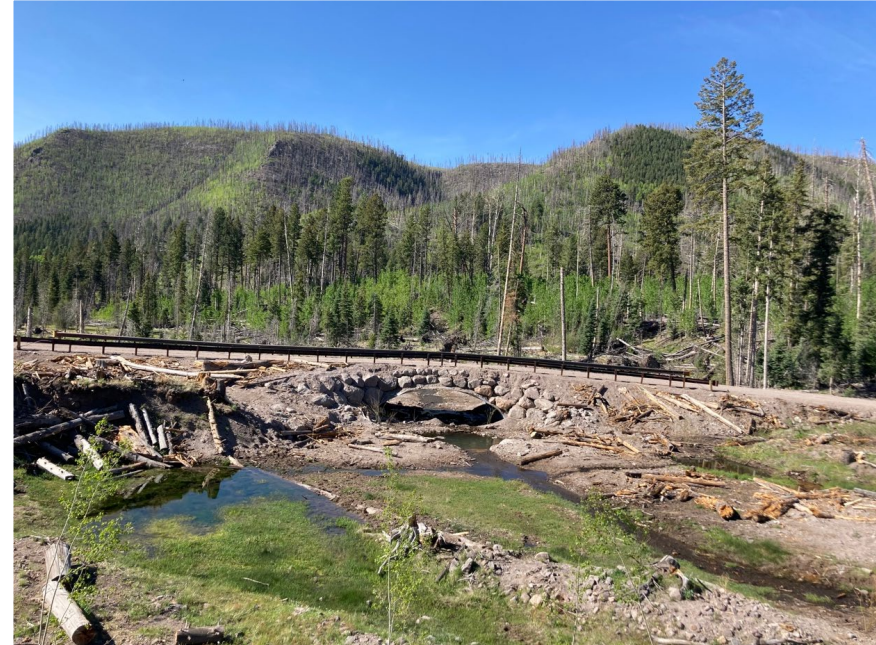
Site 1 crossing upgrade

- Incorporated stream restoration above and below
- Goal to maximize riparian habitat availability (i.e. ecological uplift)

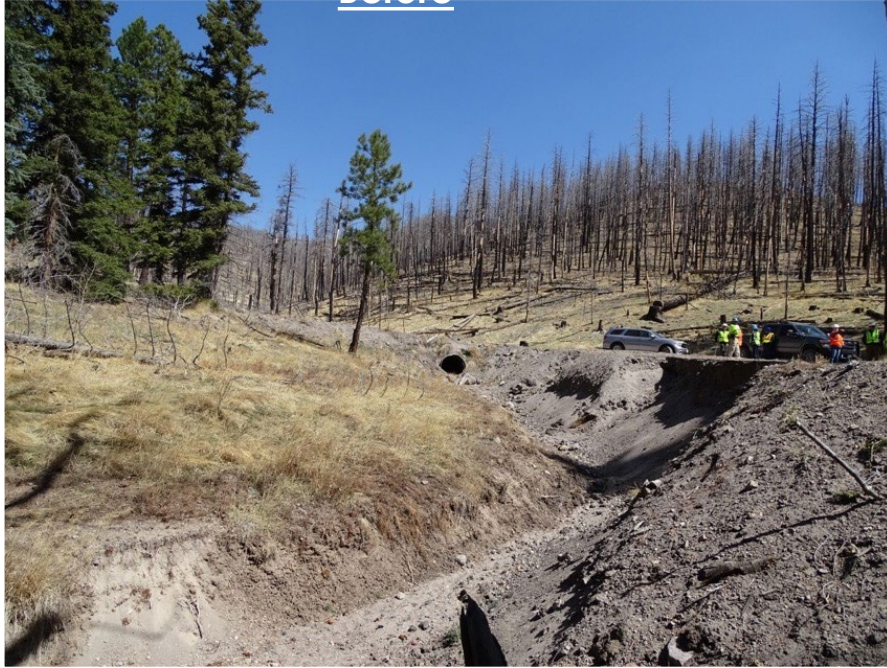
Site 2 crossing– stacked stone

36"x 40' CMP Culvert

- Cylindrical culverts provide a cost-effective alternative when set below grade.

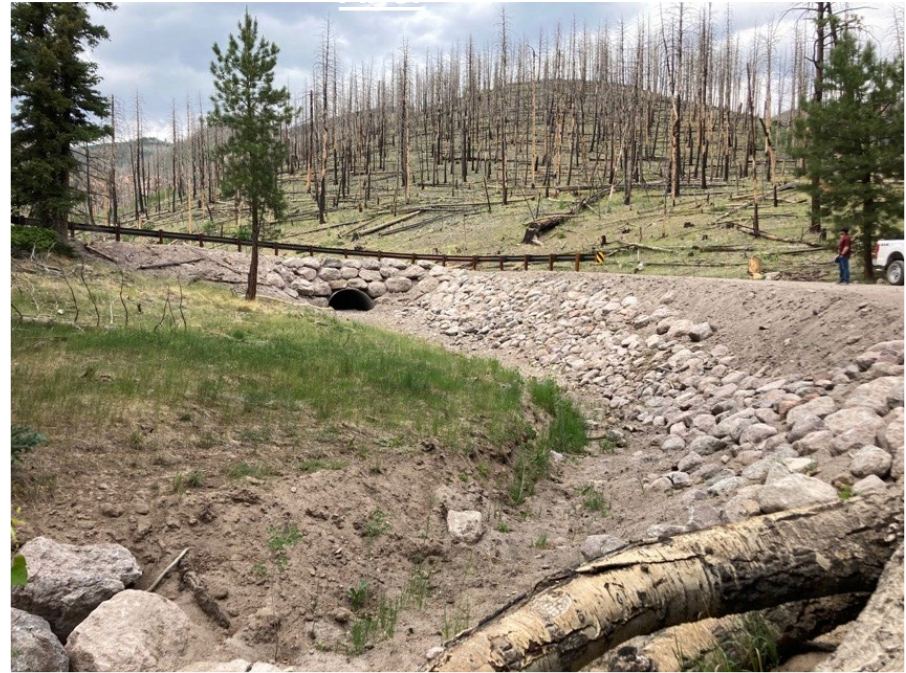
6'x 3'x 58' Bottomless Culvert

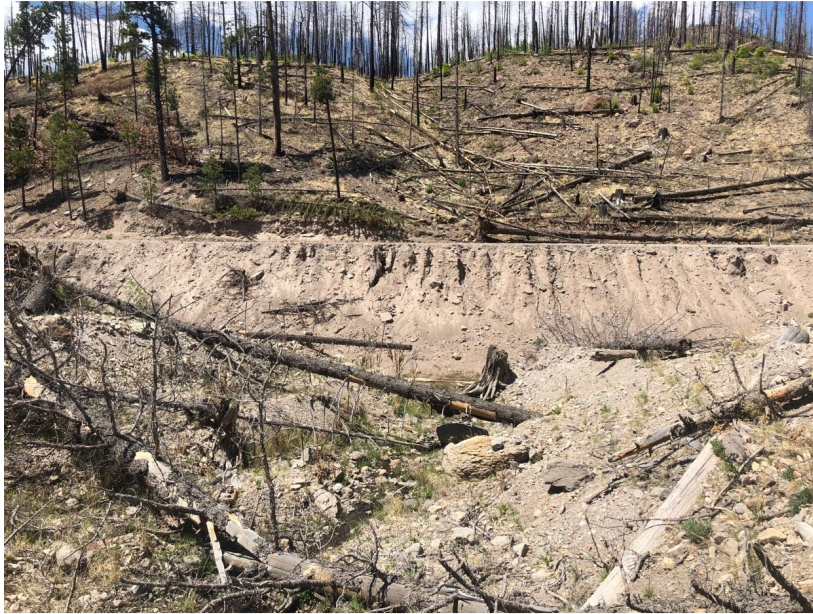
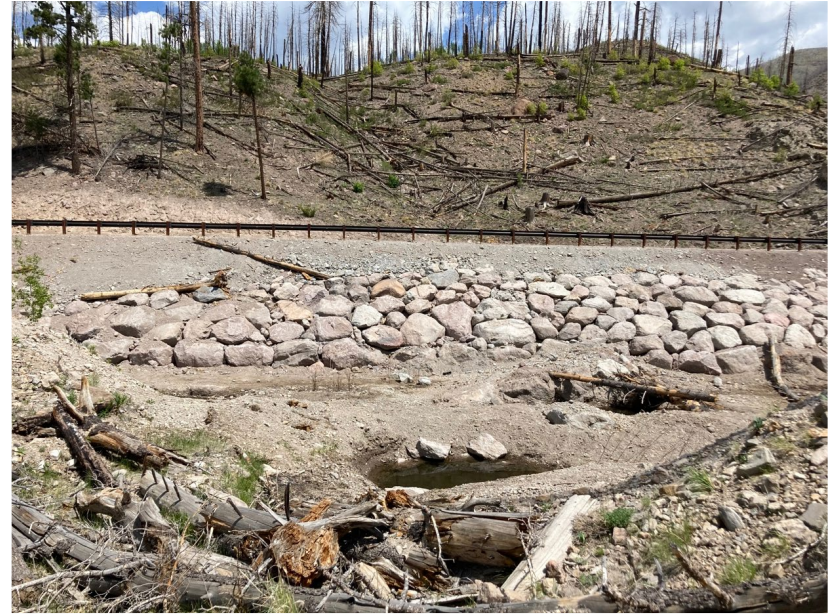
Site 3- Bank stabilization

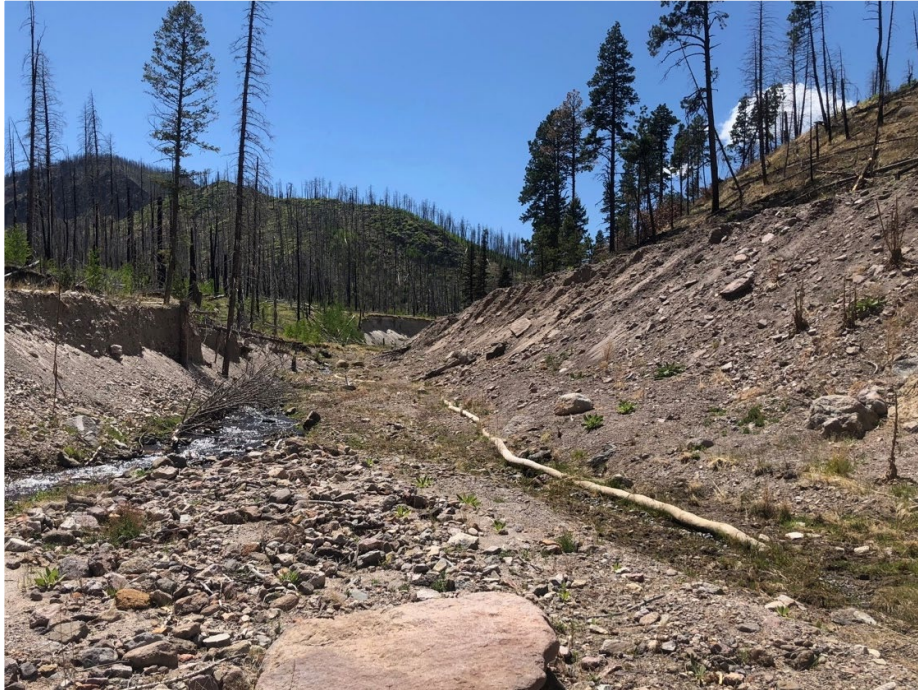
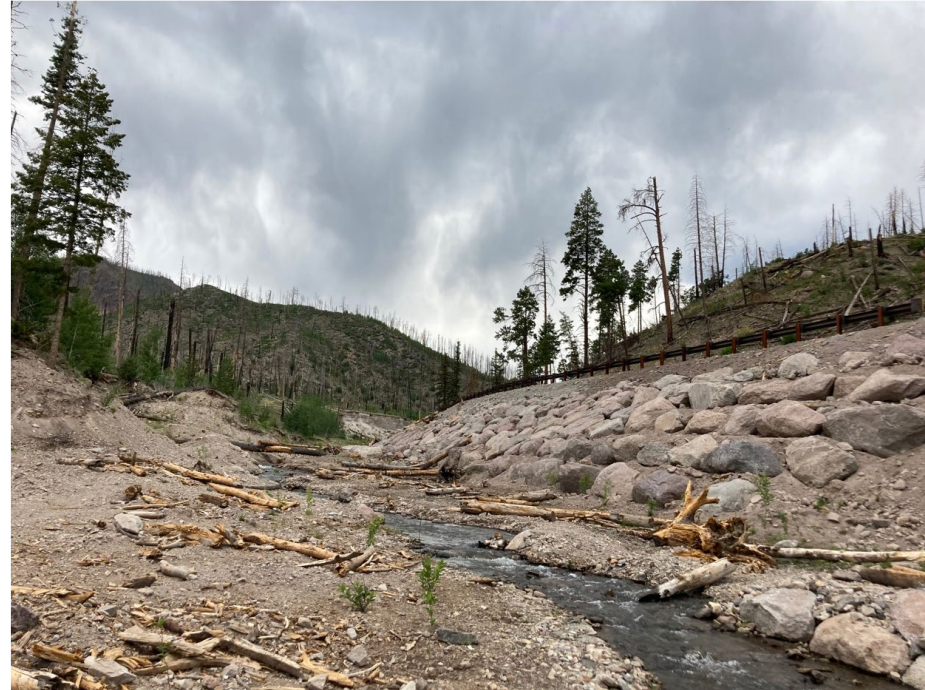
Site 3- Bank stabilization
