Case Study 1: Mores Creek Floodplain Restoration, Idaho, United States¹

Purpose of Project: Restore the stream channel and floodplain to improve lateral connectivity and fish habitat, and support the temperature and sediment impairment total maximum daily load (TMDL)

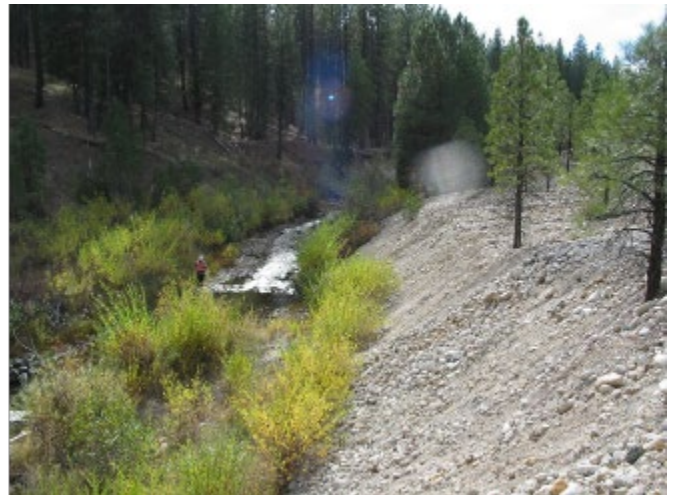
Top: Site before restoration

Bottom: Site 2 years after floodplain benching.
