Case Study 2: Garner Creek Restoration, Georgia, United States³

Purpose of Project: Restore the urban stream corridor to mitigate streambank erosion and flooding, and support the biological impairment total maximum daily load (TMDL)

Project Description

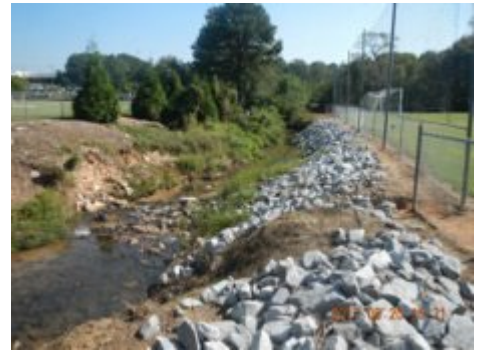
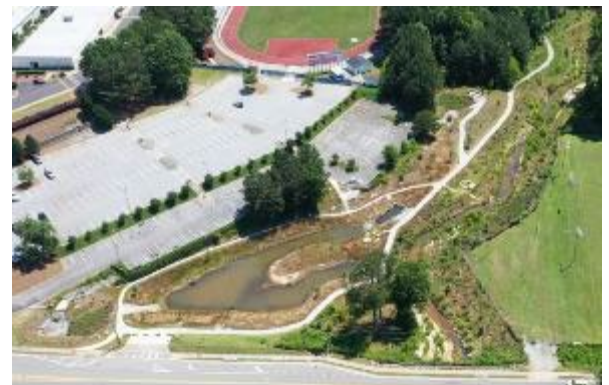
Top: Garner Creek before restoration

Bottom: After restoration.

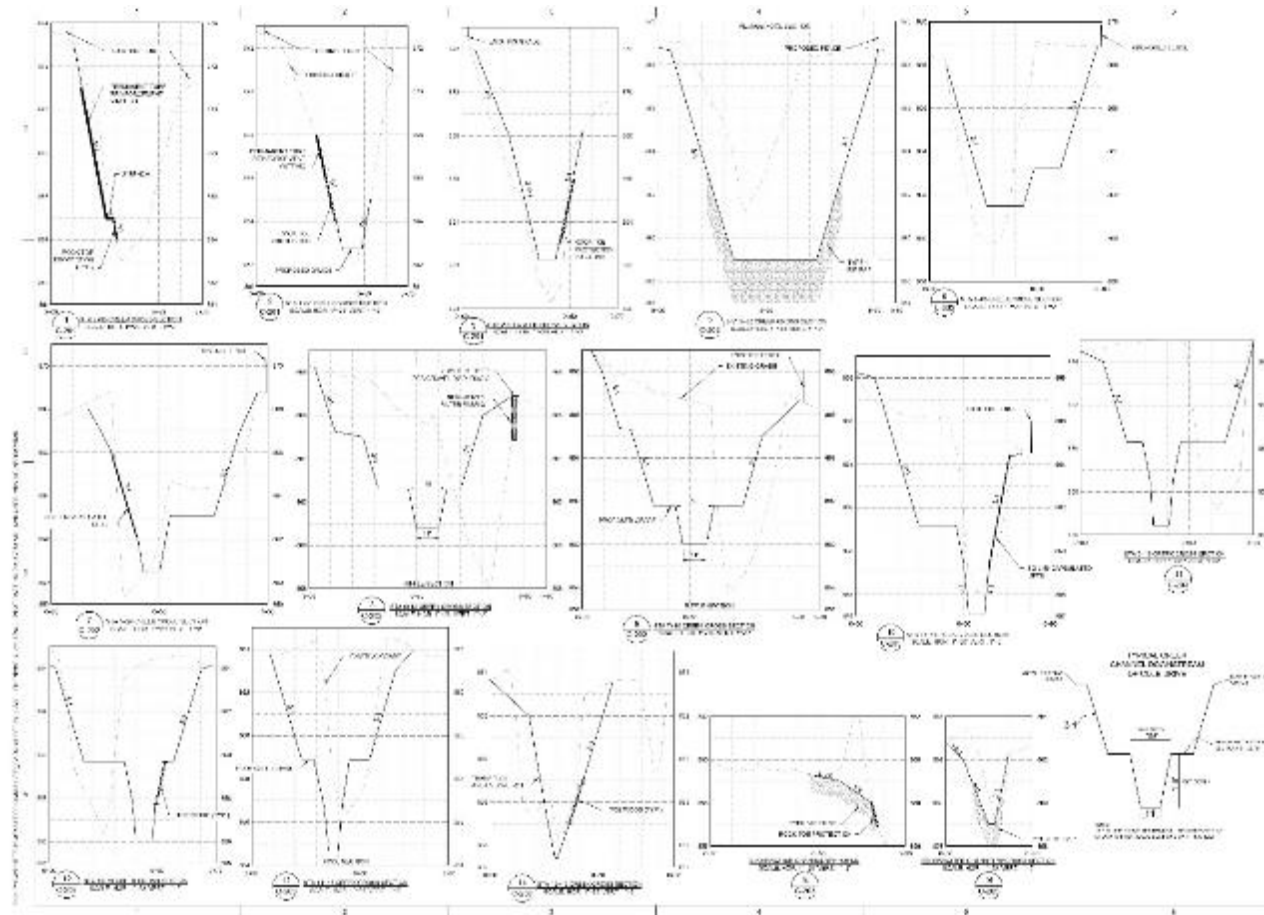
Figure 6. Select cross sections showing the bankfull bench design for the Garner Creek restoration project
Sections developed by Brown and Caldwell.⁶

The existing conditions were used to inform restoration design. Stream channel dimensions were determined by combining current conditions observed in Garner Creek with methods that had proven to withstand flashy flows in urban streams throughout Gwinnett County – reference reach measurements within the county, North Carolina Piedmont Rural Regional Curves, and Piedmont Dimensionless Ratios provided by the Gwinnett County Department of Water Resources. Proposed conditions were modeled with a one-dimensional HEC-RAS model to assess whether these dimensions could convey the bankfull discharge, approximated with the 50% annual exceedance probability flow. Floodplain benches ranging from 2 to 20 feet in width, with wider benches on inside meander bends, were modeled to quantify reduction in shear stresses on streambank side slopes at flows above bankfull. Streambank and in-stream structures such

as rock vanes, toe wood, and encapsulated soil lifts were incorporated as grade control and additional protection against erosion. Rocks were sized using a relationship between bankfull maximum shear stress and minimum rock size, published in Part 654 National Engineering Handbook.⁵ Native vegetation was selected to plant along the regraded banks and overbank area.
