Engineering With Nature

Project Fact Sheet

Ashtabula Breakwater Tern Nesting Habitat Demonstration Project

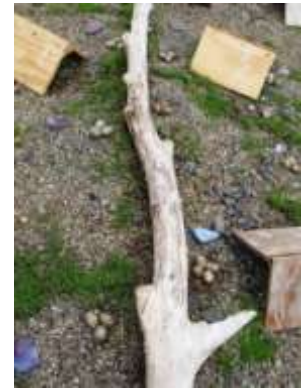
Figure 1. Tern nests with eggs and plywood chick shelters on a created nesting area.

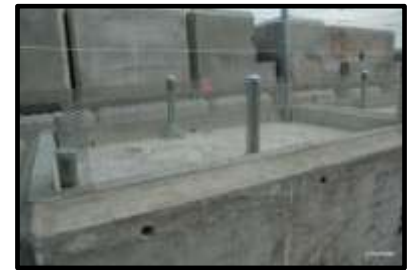
Figure 2. Tern nesting block prior to installation and the addition of gravel substrate.

The Ashtabula breakwater tern nesting demonstration project is designed to help biologists determine whether suitable habitat can be created on the harbor breakwater by making simple, low-cost modifications to the concrete blocks used to repair the breakwater. The design includes incorporation of suitable nesting substrate (gravel) and predator deterrence features. If the demonstration is successful, it will provide a means of returning the common tern (*Sterna hirundo*) to the local avian community. Historically, the common tern nested in the area, but has not been recorded locally for decades due to the lack of suitable habitat.
