NNBF Island Features

36th International Conference on Coastal Engineering

Short Course: NNBF for Coastal Resilience July 29, 2018

Monica Chasten U.S. Army Corps of Engineers Philadelphia District

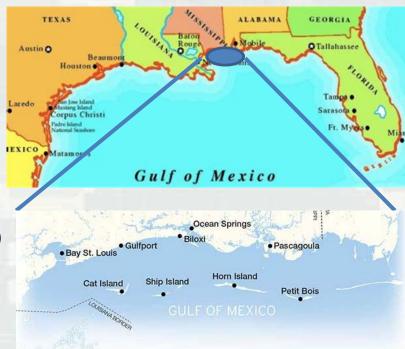
Ship Island, Mississippi Case Study

Ship Island is western-most in a string of barrier islands in the Gulf of Mexico protecting the Mississippi and Alabama Gulf Coasts from hurricane surge and short waves.

- Nourished and maintained by river discharge
- Diverse habitat including beach/dune, upland forest, SAV, and wetland
- Sediment supply severely impacted by impoundments and navigation channels
- Entire island chain degrading
- Permanent breach from Camille (1969)
- Breach greatly widened during Katrina (2005)
- Restoration for FRM value
- Owned by U.S. National Park Service Design to restore diverse habitat (ecosystem and social value)

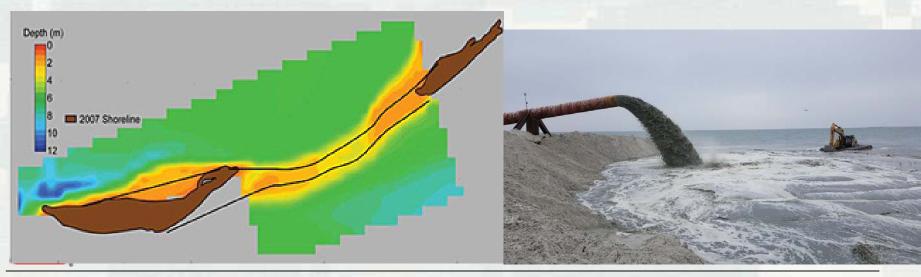
Ship Island Construction

- 15 Mm³ high quality sand from offshore source
- Contour to re-establish beach/dune, wetland and upland plant communities
- Protect remnant resources (wetland and SAV) during construction
- Support littoral zone transport using navigation dredged sediment
- Modeling supported nourishment plan increased tidal currents through gap during closure
- Plantings will support recolonization

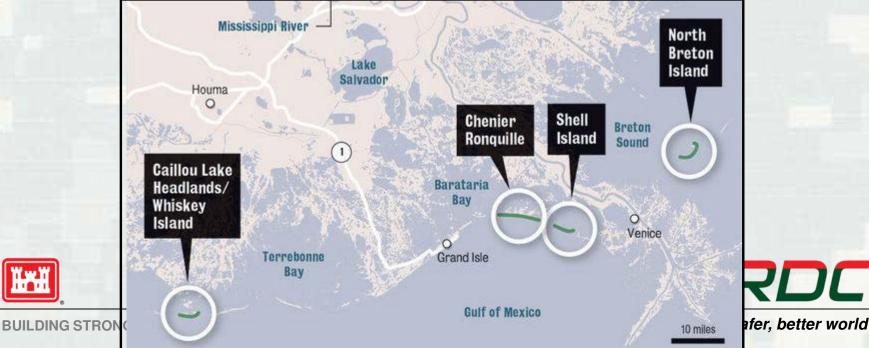
Louisiana Barrier Island Case Study

- Barrier Island chains have traditionally protected vast wetlands along the Louisiana coast
- Island/wetland system protects low-lying inland communities from flooding
- Both barrier island and wetland systems are degrading → rapid land loss and vulnerable communities
- Restoration of both island and wetland systems is ongoing
- Maintenance will be required because of reduced river sediment loads

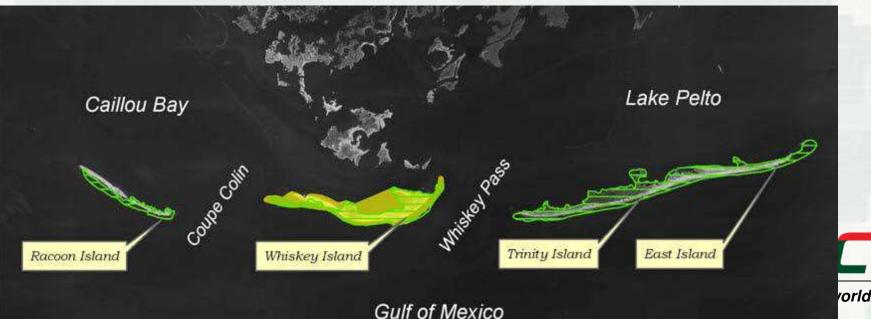
Isle Deniers Chain

- Whiskey Island loss rate of 24 acres/year in the late 20th century
- Predicted to be completely submerged by 2010
- Phased restoration projects from 1999-present,
- Maintenance will be required because of reduced river sediment loads, subsidence, SLR and other processes
- Whiskey Island restoration designed to resist breaching during events
- Island over wash and roll-over included in design

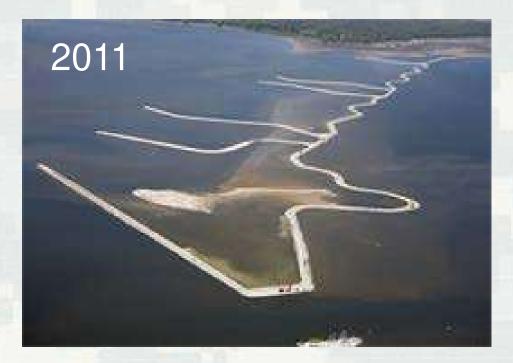
Restoring Coastal Island Features Cat Island, Wisconsin Case Study

- 1.6 Mm³ dredged sediment capacity
- Reduced dredging costs
- 110 hectares of wetland and island habitat
- Shore protection for the City of Green Bay
- Possible future placement
 capacity to maintain the system
- Three USACE mission areas addressed simultaneously
 - Flood risk management
 - Navigation
 - Ecosystem restoration

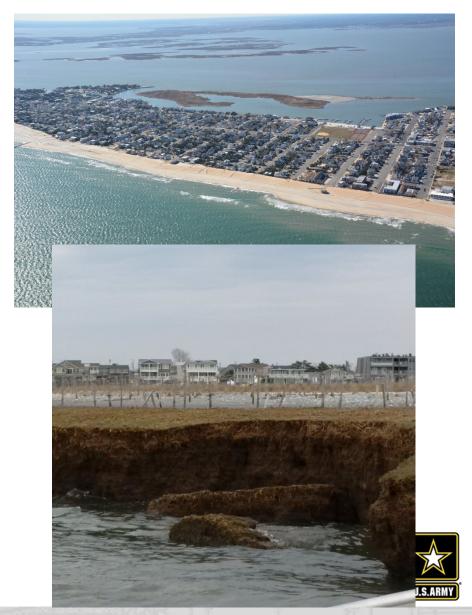
MORDECAI ISLAND PROJECT AREA

- Mordecai Island is composed of approximately 45 acres to the west of Beach Haven, Long Beach Island, NJ
- Island provides critical habitat to numerous species including the American Oystercatcher, Black Skimmer and American Bittern as well as terrapins
- Provides coastal protection for the back-bay community of Beach Haven
- Property owned by the Mordecai Land Trust

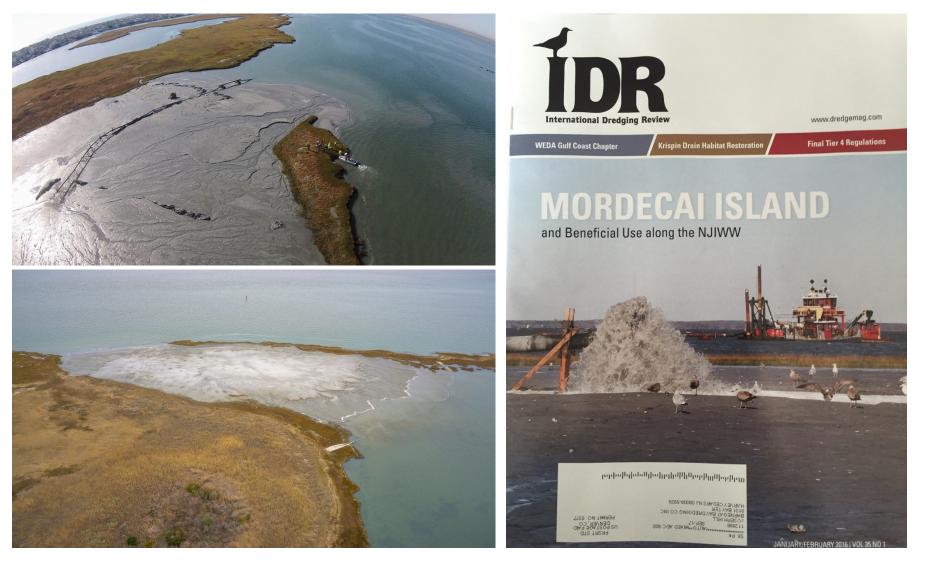
MORDECAI ISLAND CONSTRUCTED! NOVEMBER 2015

Contractors: Barnegat Bay Dredging Company, Fish Tec Inc. and GreenVest LLC
